Perilous Stairs
by Pecorella Contracting and Consulting
126 Frank Street Medina, NY 14103

Inspection Report by Superb Carpenter

May 23, 2004

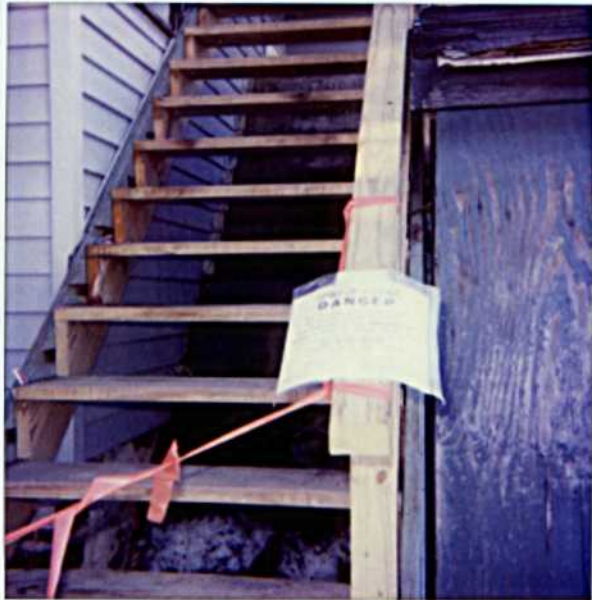
I'm surprised that no one got injured in the two months that the structure was there. This stairway was an accident just aching to happen. It is abundantly clear that the entire fabrication was in violation of the codes, rules, and regulations of NYS, which would have required proper diligence and care during the erection of a stable stairway. Obviously, the Code Enforcement Officer had no choice, but to condemn this contractor's work as unsafe.

Shows that the stairway was condemned

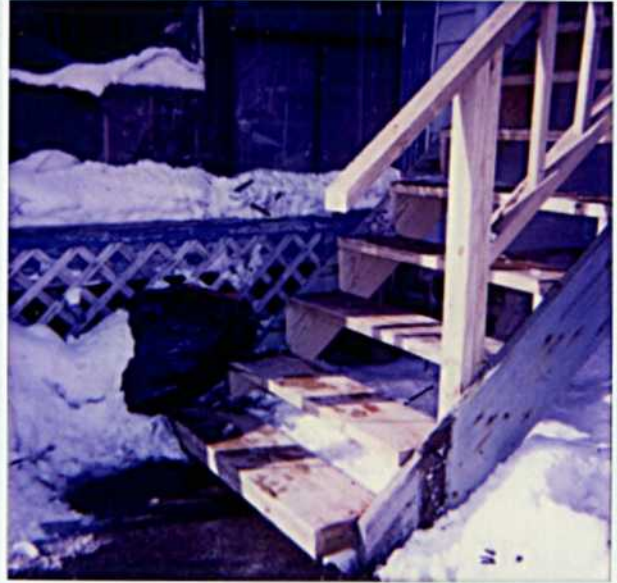
The worst factor was that new stringers were attached to old, deteriorated wood (which should have never been considered for use in building this staircase) and very poorly at that! The new wood stringers had very few screws driven into the old wood, and there was a gap of approximately 1/4" between these on one side. In addition, the one old stringer was barely secured by only a few nails and screws to the house's outer wall. The opposite old stringer had none securing it to anything.

Shows how the stairway used the old, rotten wood as its basis. Also shows the span in between the spindles.

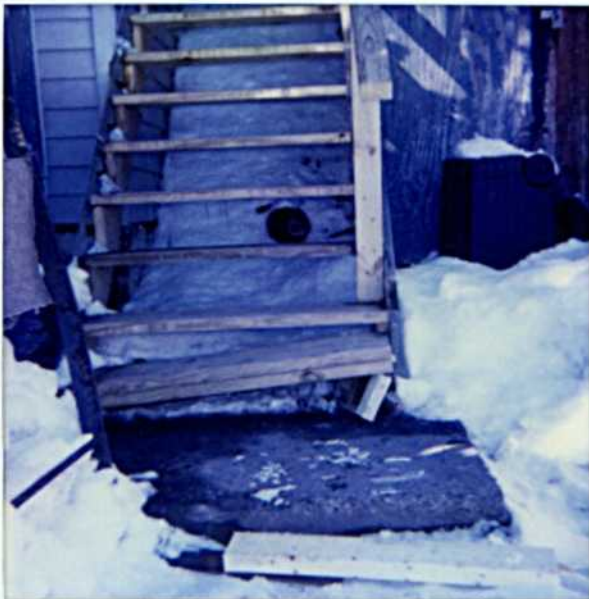
The bottom step was partially detached when I first looked at the stairway. Upon investigation, I found that this occurred because the stringer on both sides supported only the rear 4.25 inches of the step tread. The front 5 inches were not supported by anything. This scenario made it inevitable that the step would break loose as people walked on it.

Shows my "liftable" bottom step; propped up by a white board for the purpose of taking the picture.

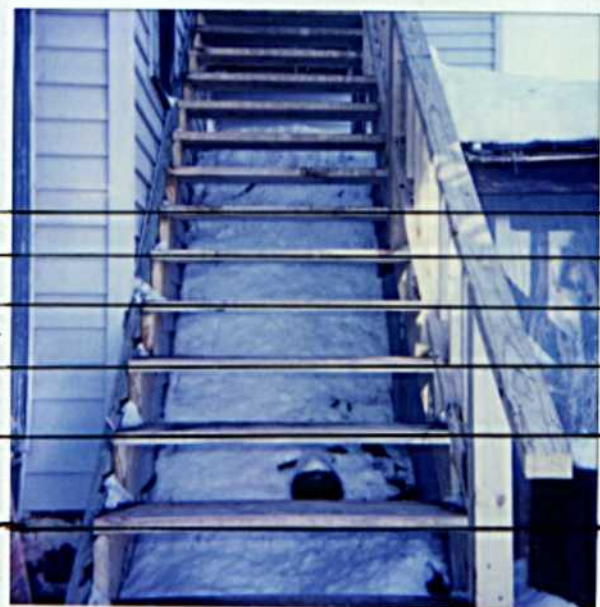
I noticed that the fifth step was not near level - a dangerous slip factor when it becomes icy.

These lines were drawn to accentuate that the step below the area marked with the small arrow was not level.

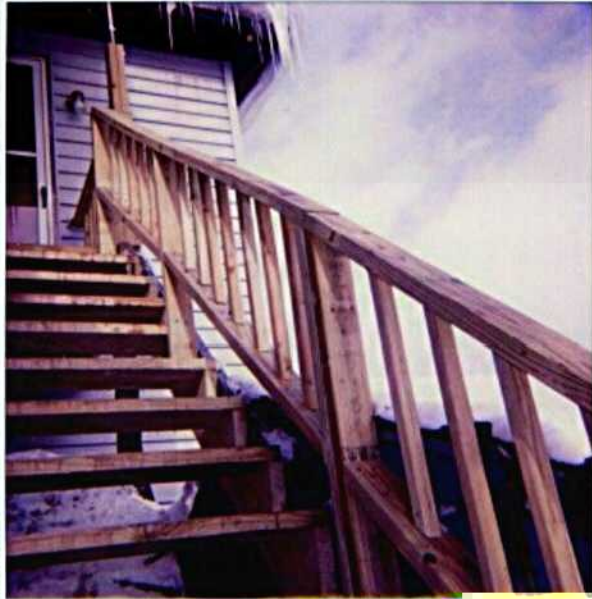
The handrail violated many building codes, and was ridiculous looking. The spindles were not parallel to each other, and varied in length. Measurements of the spindle lengths in the top

section of the handrail best illustrate how insolently this contractor built this handrail. The spindle at the bottom of this section measured 20" and the spindles at the top of this section measure 16 3/4". Even two handrail uprights weren't parallel to each other, and therefore both could not have been perpendicular to the ground. Distances apart measured 61 1/4" at the top, and 55" at the bottom.

Shows how crooked and ugly the handrail was. Spindles were not placed evenly or parallel.

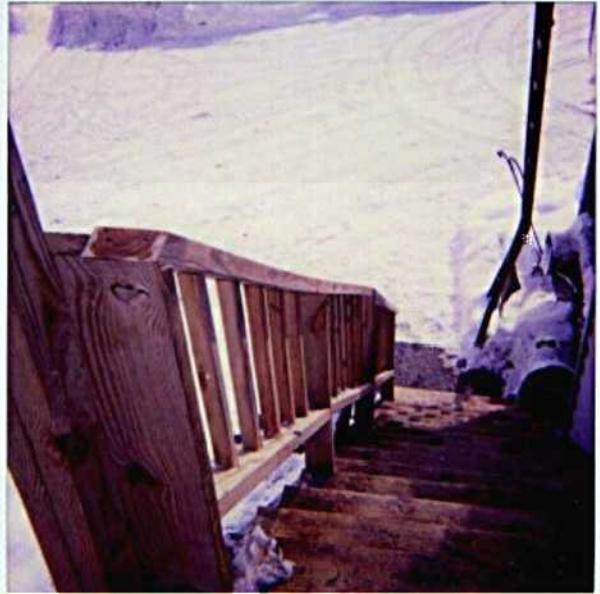
There is still another defect in the handrail. All spaces should be no wider than 4" so a toddler's head cannot pass through. I found the spaces in between the railing's spindles were 6" up to 8 3/4" wide. A toddler at the second story could fall through these wide spaces to his / her death.

Spans were too wide, up to 8.75 inches - Code is less than 4 inches

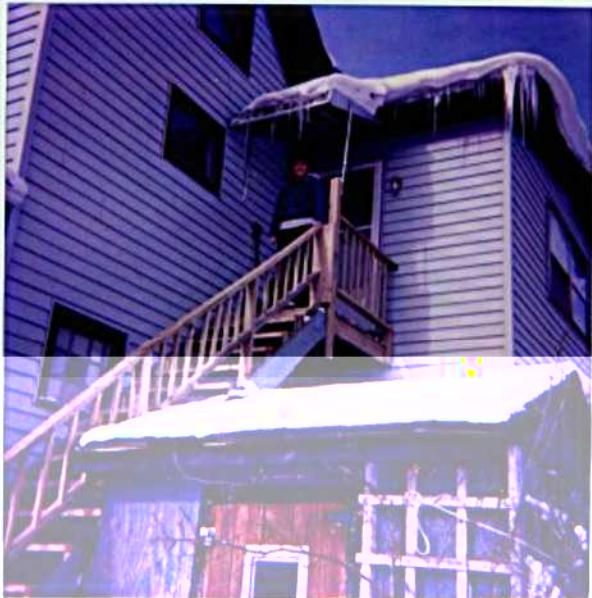
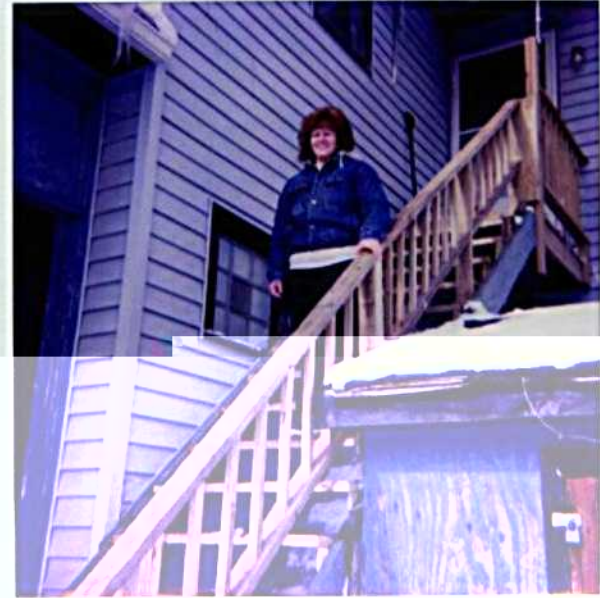
One upright was 39" tall, and the upright at the top was only 33" tall (too low for the standard). A person automatically expecting the handrail at the top to be a uniform height with the rest of the handrail might possibly grab for the rail and miss, as the handrail would have been 6" below their reach. Injury or death is a real possibility, especially since this resulting fall would have been from two stories high.

These two pictures show that the handrail was different heights. My arm is straight at the top. Height = 33 inches

My arm is bent at half-point. Height = 39 inches

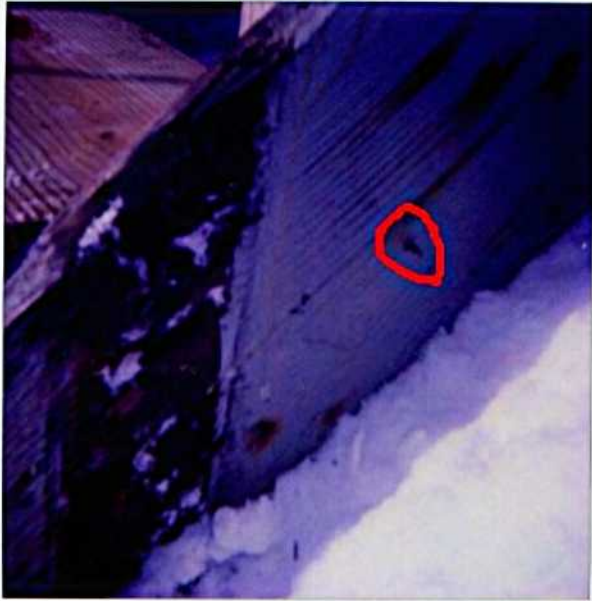
Shows the rotten wood that is the main support for the stairway. Also shows a screw point.

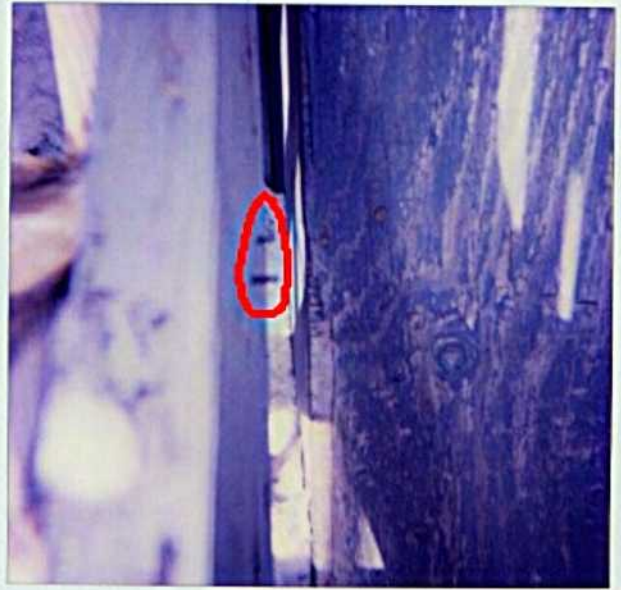
There were five tips of screws protruding out from the lower section of one old stringer where someone could walk by, and be injured. These sharp projections ranged in length from 1/4" to 9/16". It was hazardous just being next to these steps, let alone being on them.

Shows more screw points protruding out where they could injure someone.

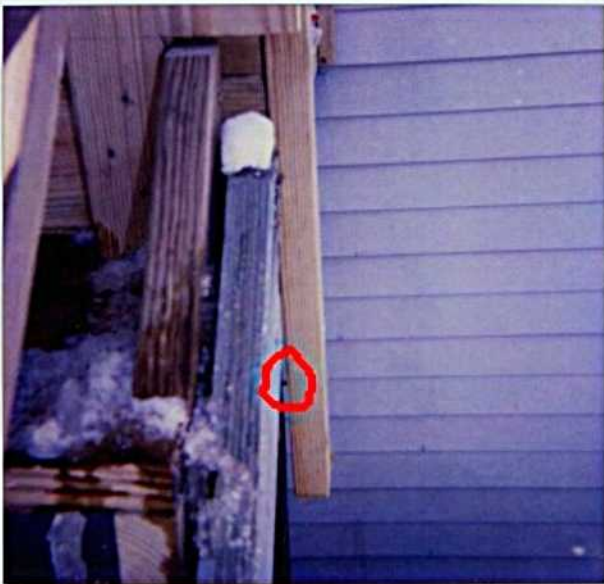
Shows the pitiful attempt at securing this board. You can see the one screw between the gap of new against old.

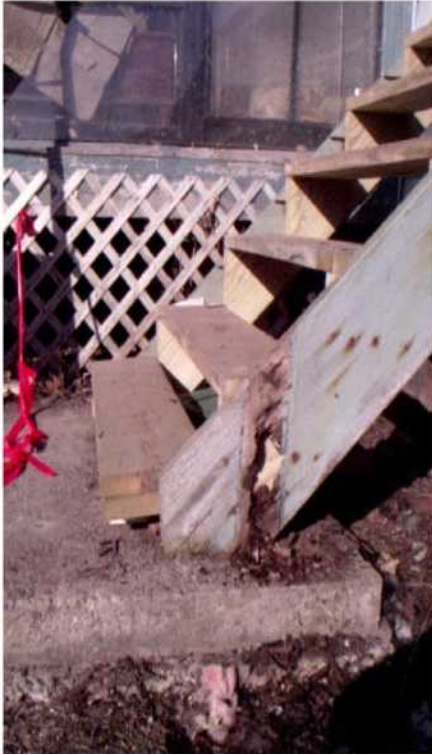
On the day that I dismantled this staircase, I tapped lightly with a hammer on one area of the rotten wood. The deteriorated wood crumbled away creating a hole measuring 4" x 4". A little more tapping, and I'm sure that the bottom few inches of the stringer would have fallen off.

As new contractor was rebuilding, he tapped lightly with a hammer on the rotten wood. This resulted in putting a hole clean through the rotten wood.

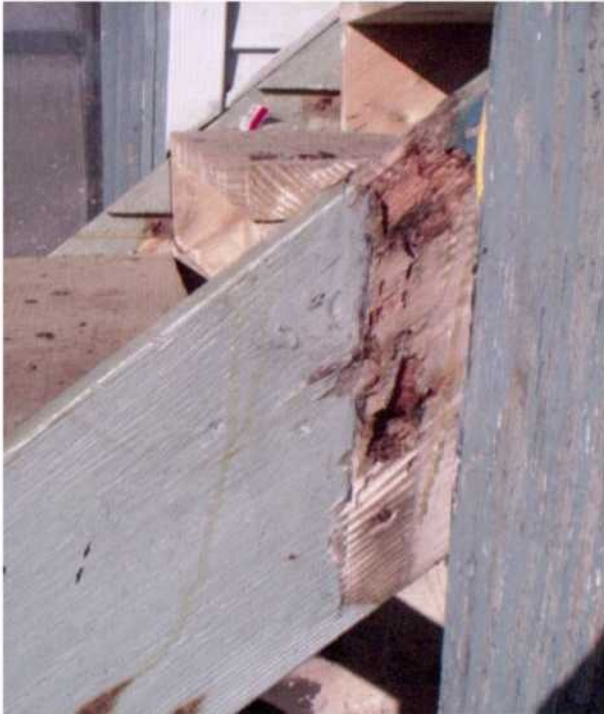
Another example of the rotten wood

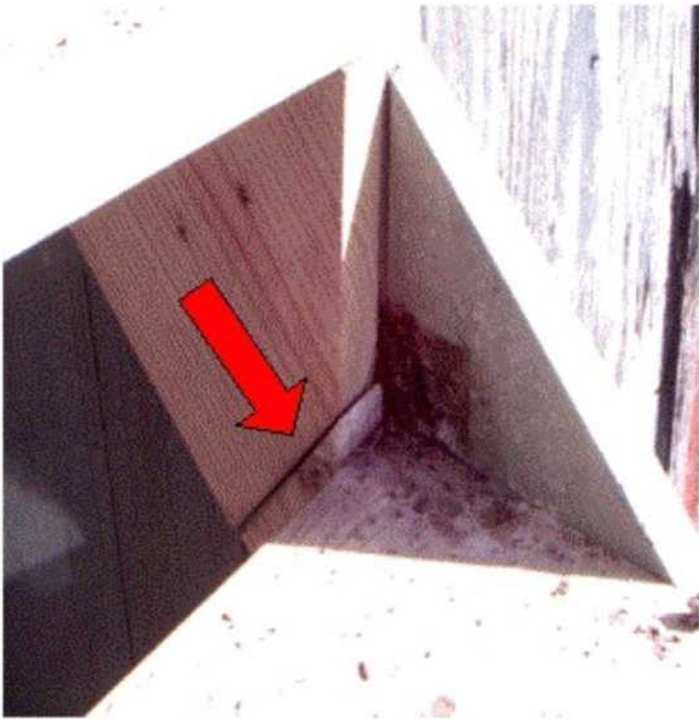
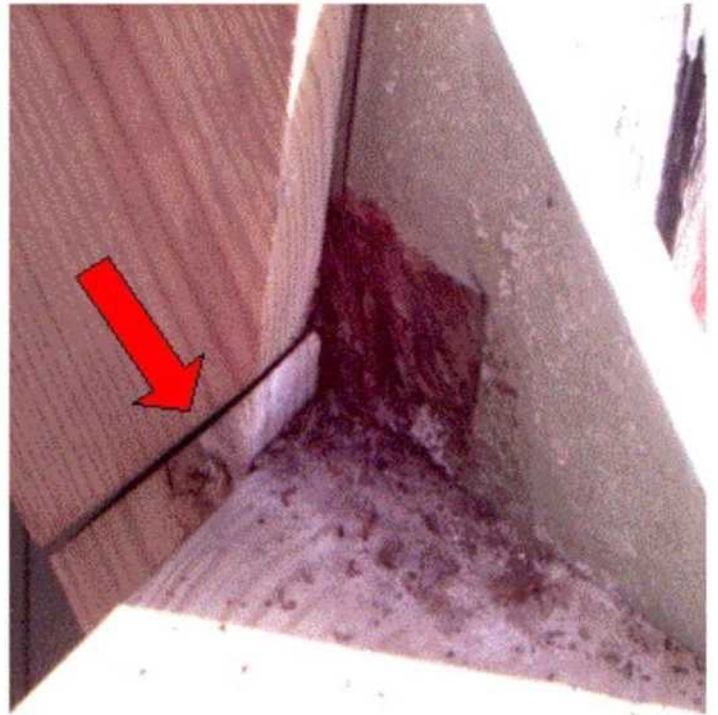
Lastly, any staircase over 10 steps is required to have continuous stringers that are notched for the treads to be inserted. The new stringers built by this contractor were not of a continuous length as they should have been for proper structural support. Three sections measuring 5.5, 5.5, and 6 feet were fastened to the old wood. In essence, the deteriorated, crumbling, old wood was not used just for filler, but as the base for the new stairway. Also, I noticed as I removed the handrailing, that the joints of the stringers were extremely unsafe. The seams were at approximately a 45-degree angle to the ground. These seams should have (at the very least) been parallel to the ground. This configuration left this structure too treacherous for any occupancy, as it depended on the old crumbling wood as its main support. When the old wood deteriorates a little more, there will be nothing to keep the new wood from collapsing.

These pictures show the despicable method that Pecorella used to mount the new wood against the old-rotten wood. It is clearly shown that the rotten wood is the main support for everything above the bottom section. And then, this junction is slanted, making it virtually unsupported, and able to slide right down. The only thing preventing this slide are the screws holding the new wood to the rotten wood. Once the rotten wood deteriorates a little more, the stairway will fall apart, probably with a person on it.

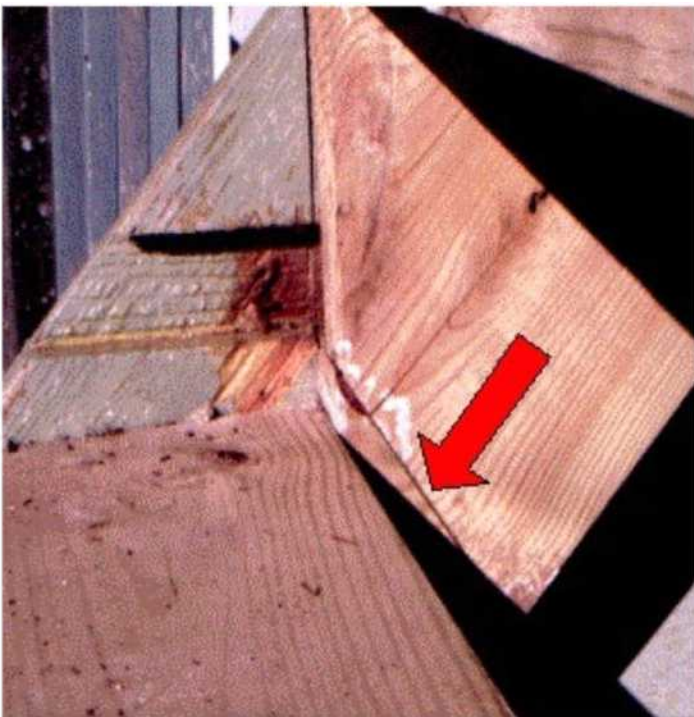
The matching joint on the opposite side

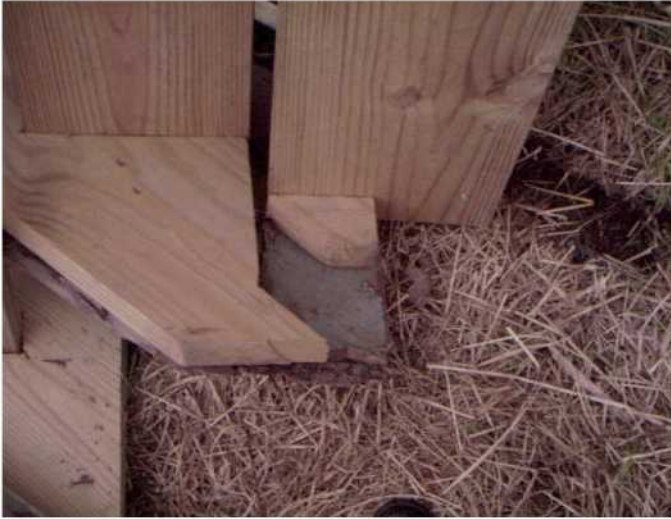
This is the bottom step as shown from underneath. It shows that the front five inches were not supported by anything. It was inevitable that the step would break loose as people stepped on it.

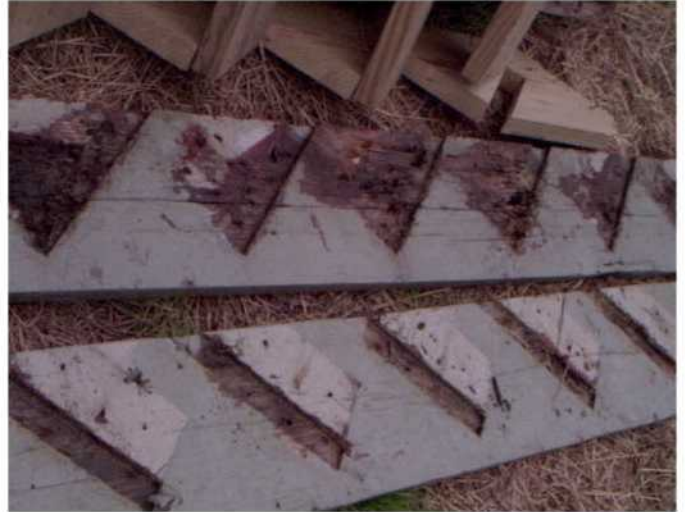
This is a picture of the old, rotten wood that Pecorella used as the basis (stringers) for the stairway.

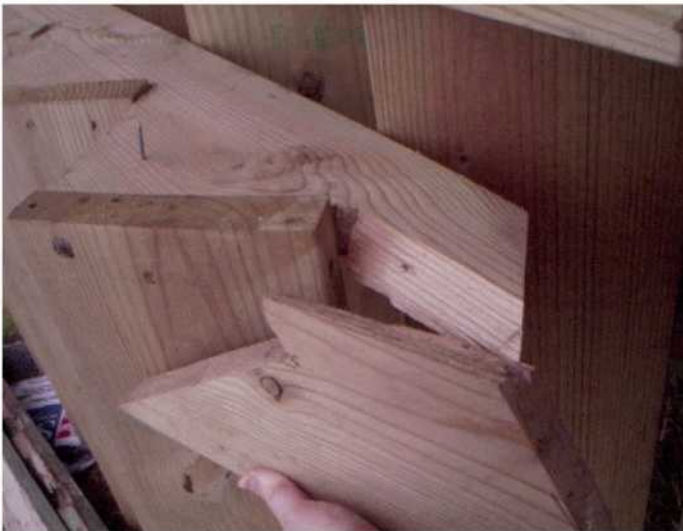
The top step tread was inserted into a slot, and then secured only by one screw at each side. Subsequently, as I was dismantling the top section, the very tip of the stringer broke off in my hand. It looked suspiciously like the contractor knew of the split, and tried to fix it with one screw.

This is a piece of wood that broke off in John's hand as he was taking the stairway down. This is at the very top of the stairs

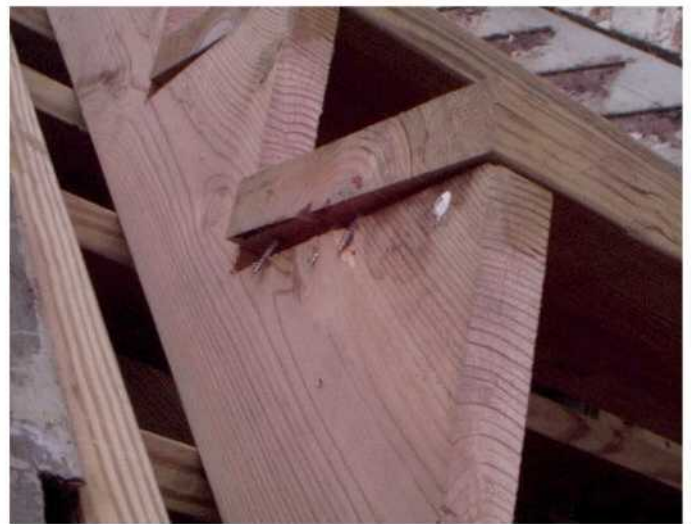
The fourth step from the top had 3 screws on one end that did not penetrate into the stringer. This step would quickly become detached.

This shows three screws that missed the stringer. They are holding nothing! You can see that the tread is already lifting away from the stringer.

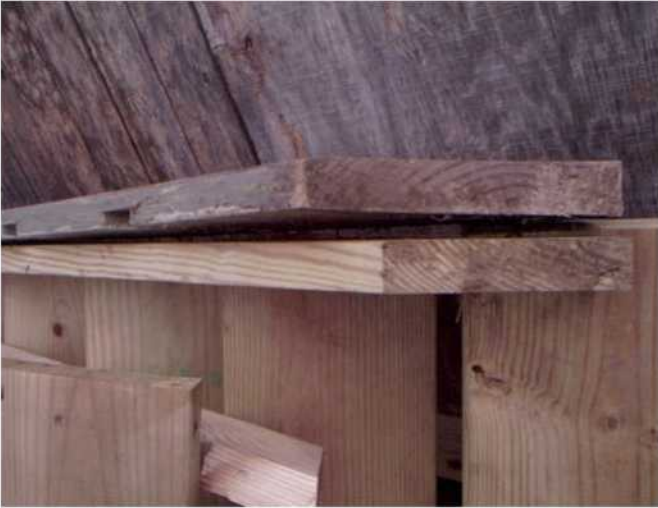
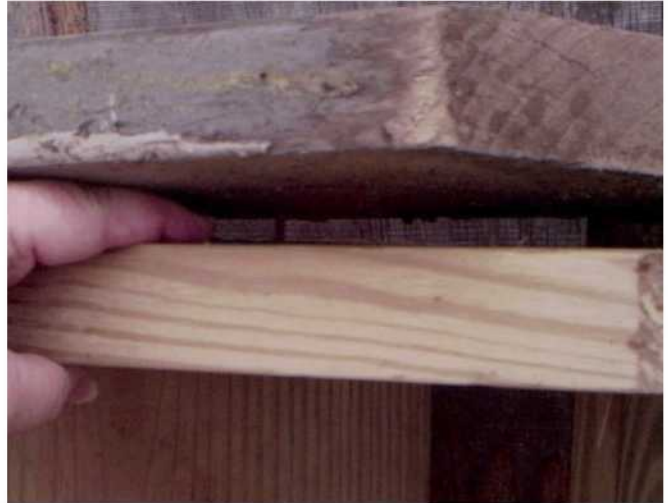
These two pictures show how poorly the new wood stringers were fastened to the old rotten stringers. In the picture on the right, I placed my finger into the gap in order to illustrate the span.

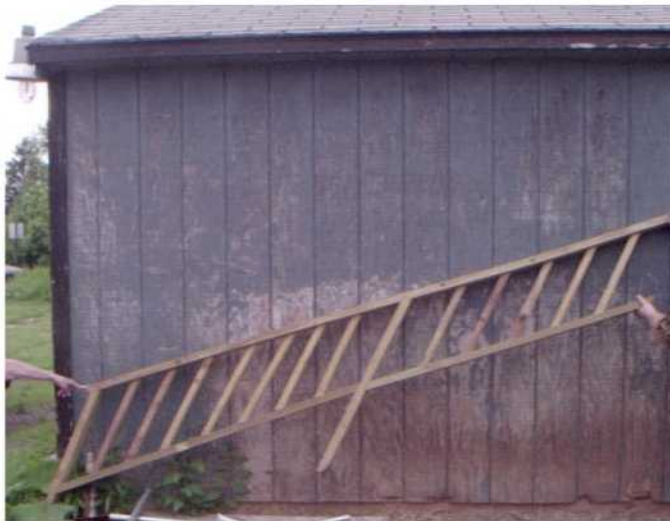
This is a picture of the top section of my ugly, crooked hand-rail. Look at the span just above support (about midway). That span, which is required by NYS Code to be less than 4 inches wide so a toddler's head can't fit through, is actually 8.5 inches wide.
