# Roofing Infractions

RE: Inspection of ***GAF Materials Corporation*** Roofing System

As per your request, I inspected a GAF Roofing System at the residence located at 17029 Gulf Road, Holley, NY on March 29, 2004. This letter is to document my findings.

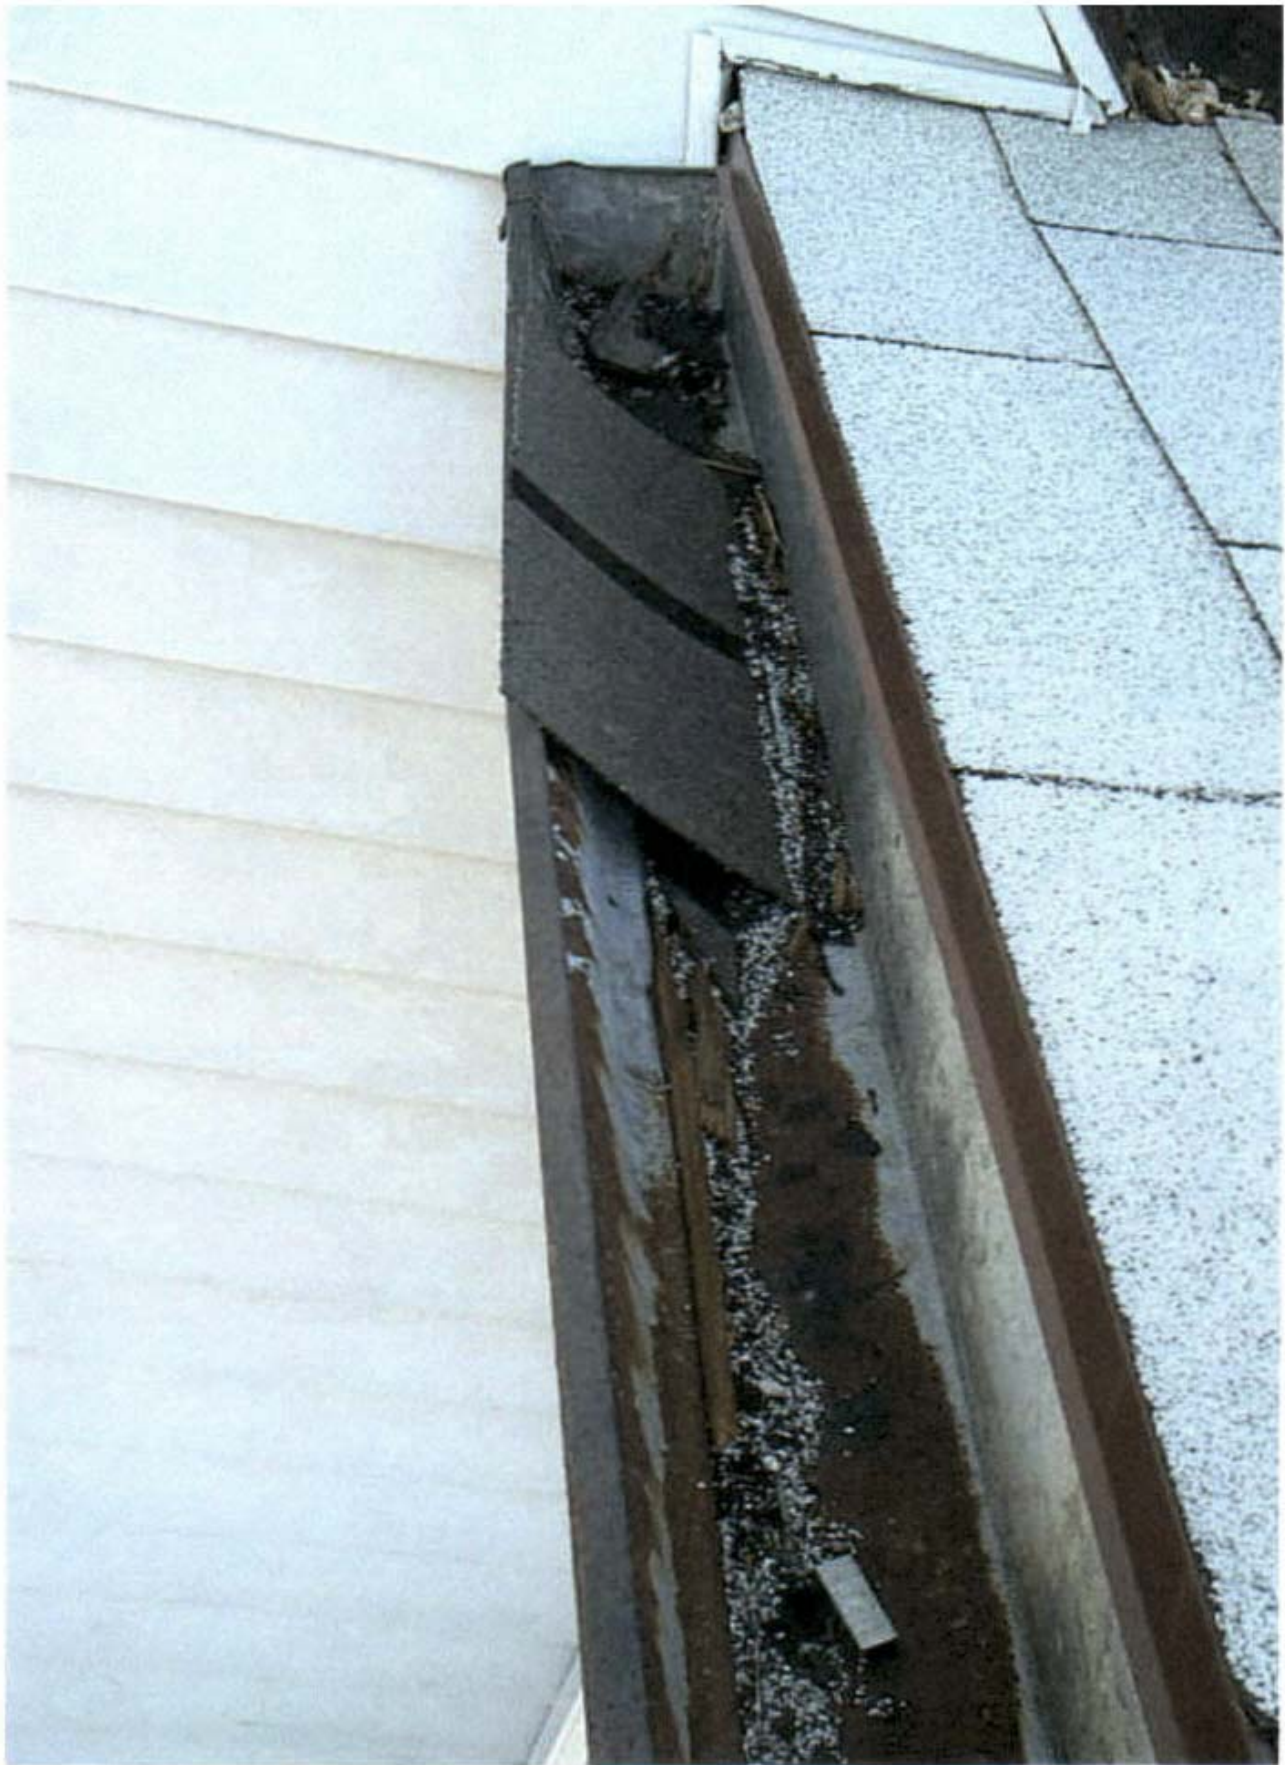
Debris that the crew left in one of the gutters. Shows that the roof is flush to the wall – no overhang into the gutters as dictated in the Manufacturer's specifications. Water will leak into the wall behind the siding. (Photo by Professional Home Inspection Services)

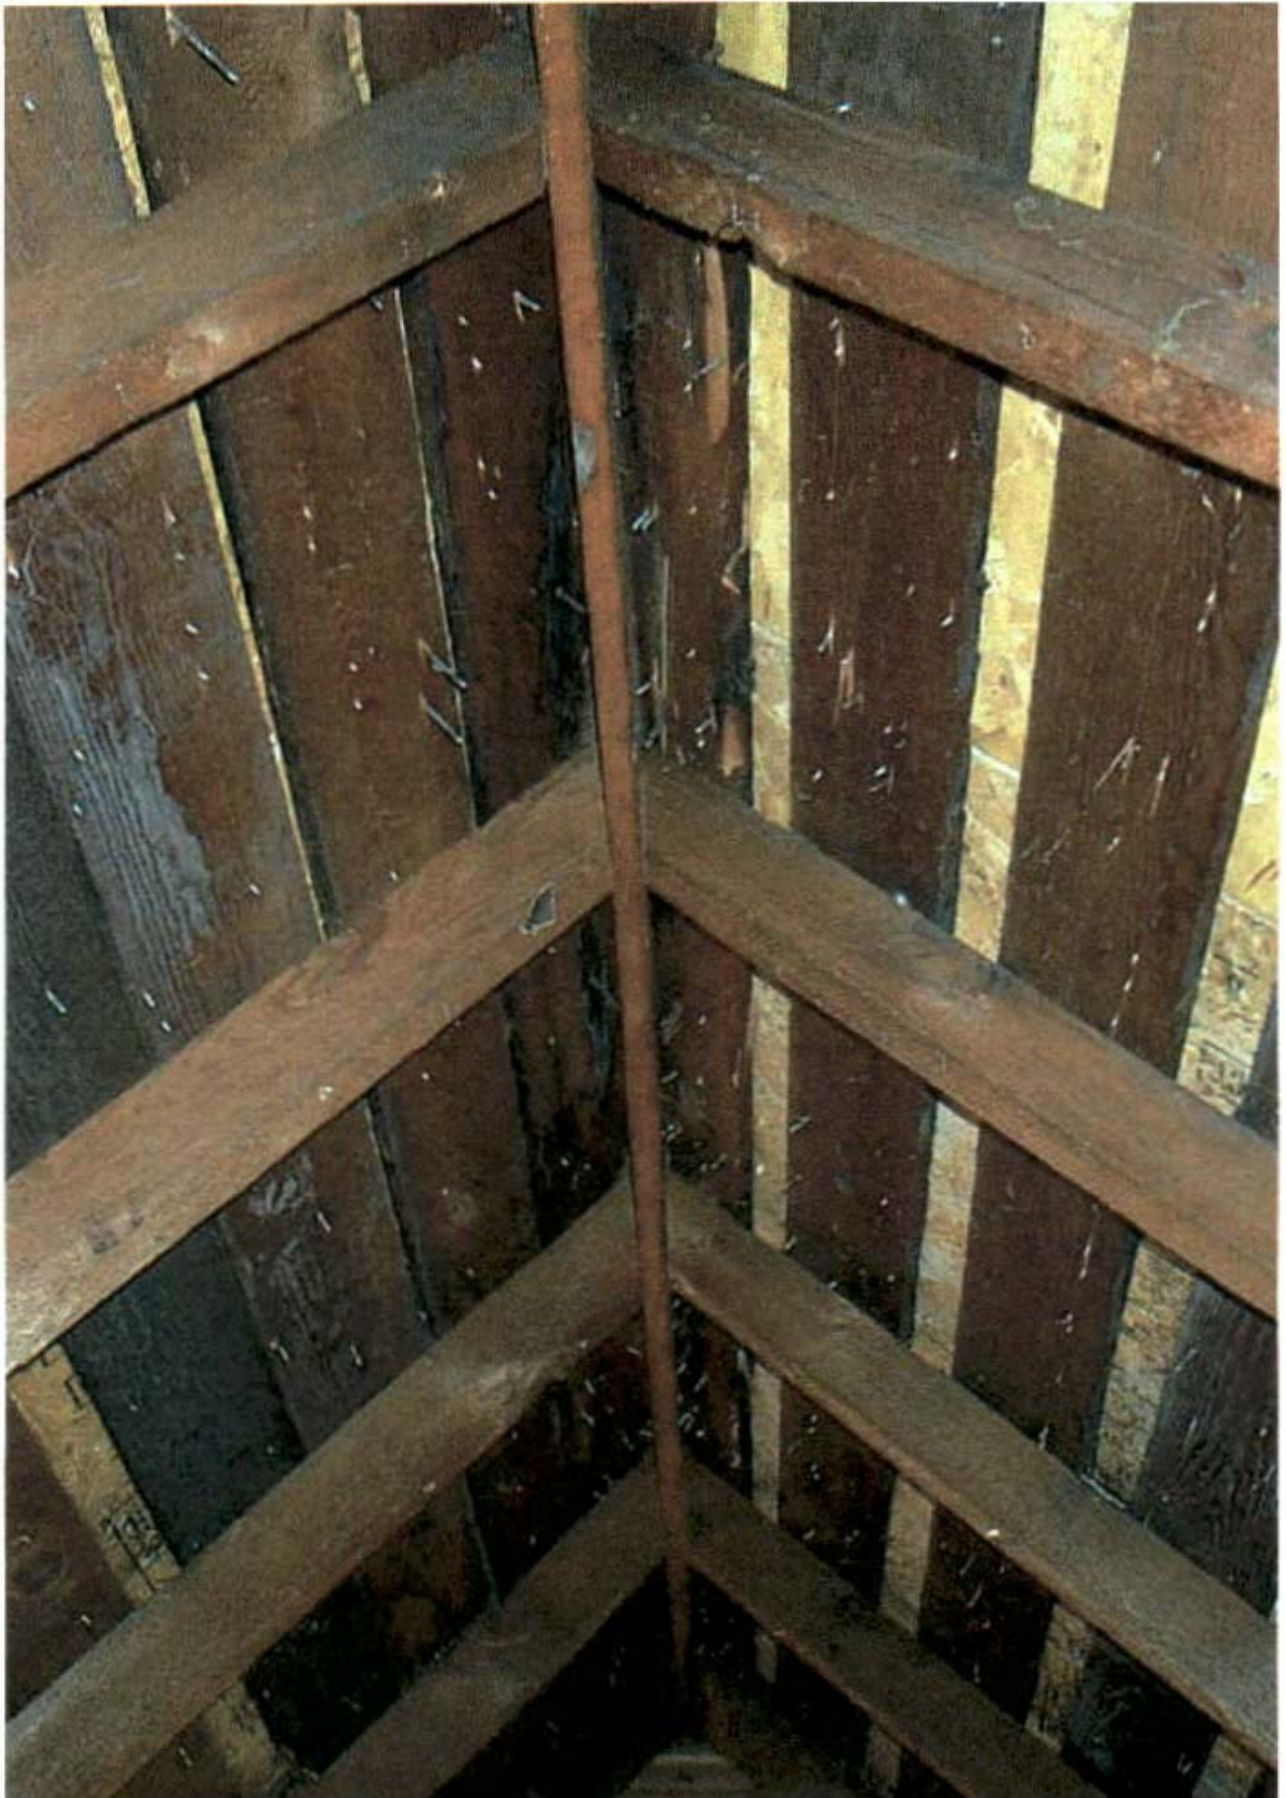
Attic framing was not cut through at any of the four peaks to allow warm air to flow out. Ventilation system purchased by homeowner is effectively non-existent. (Photo by Professional Home Inspection Services)

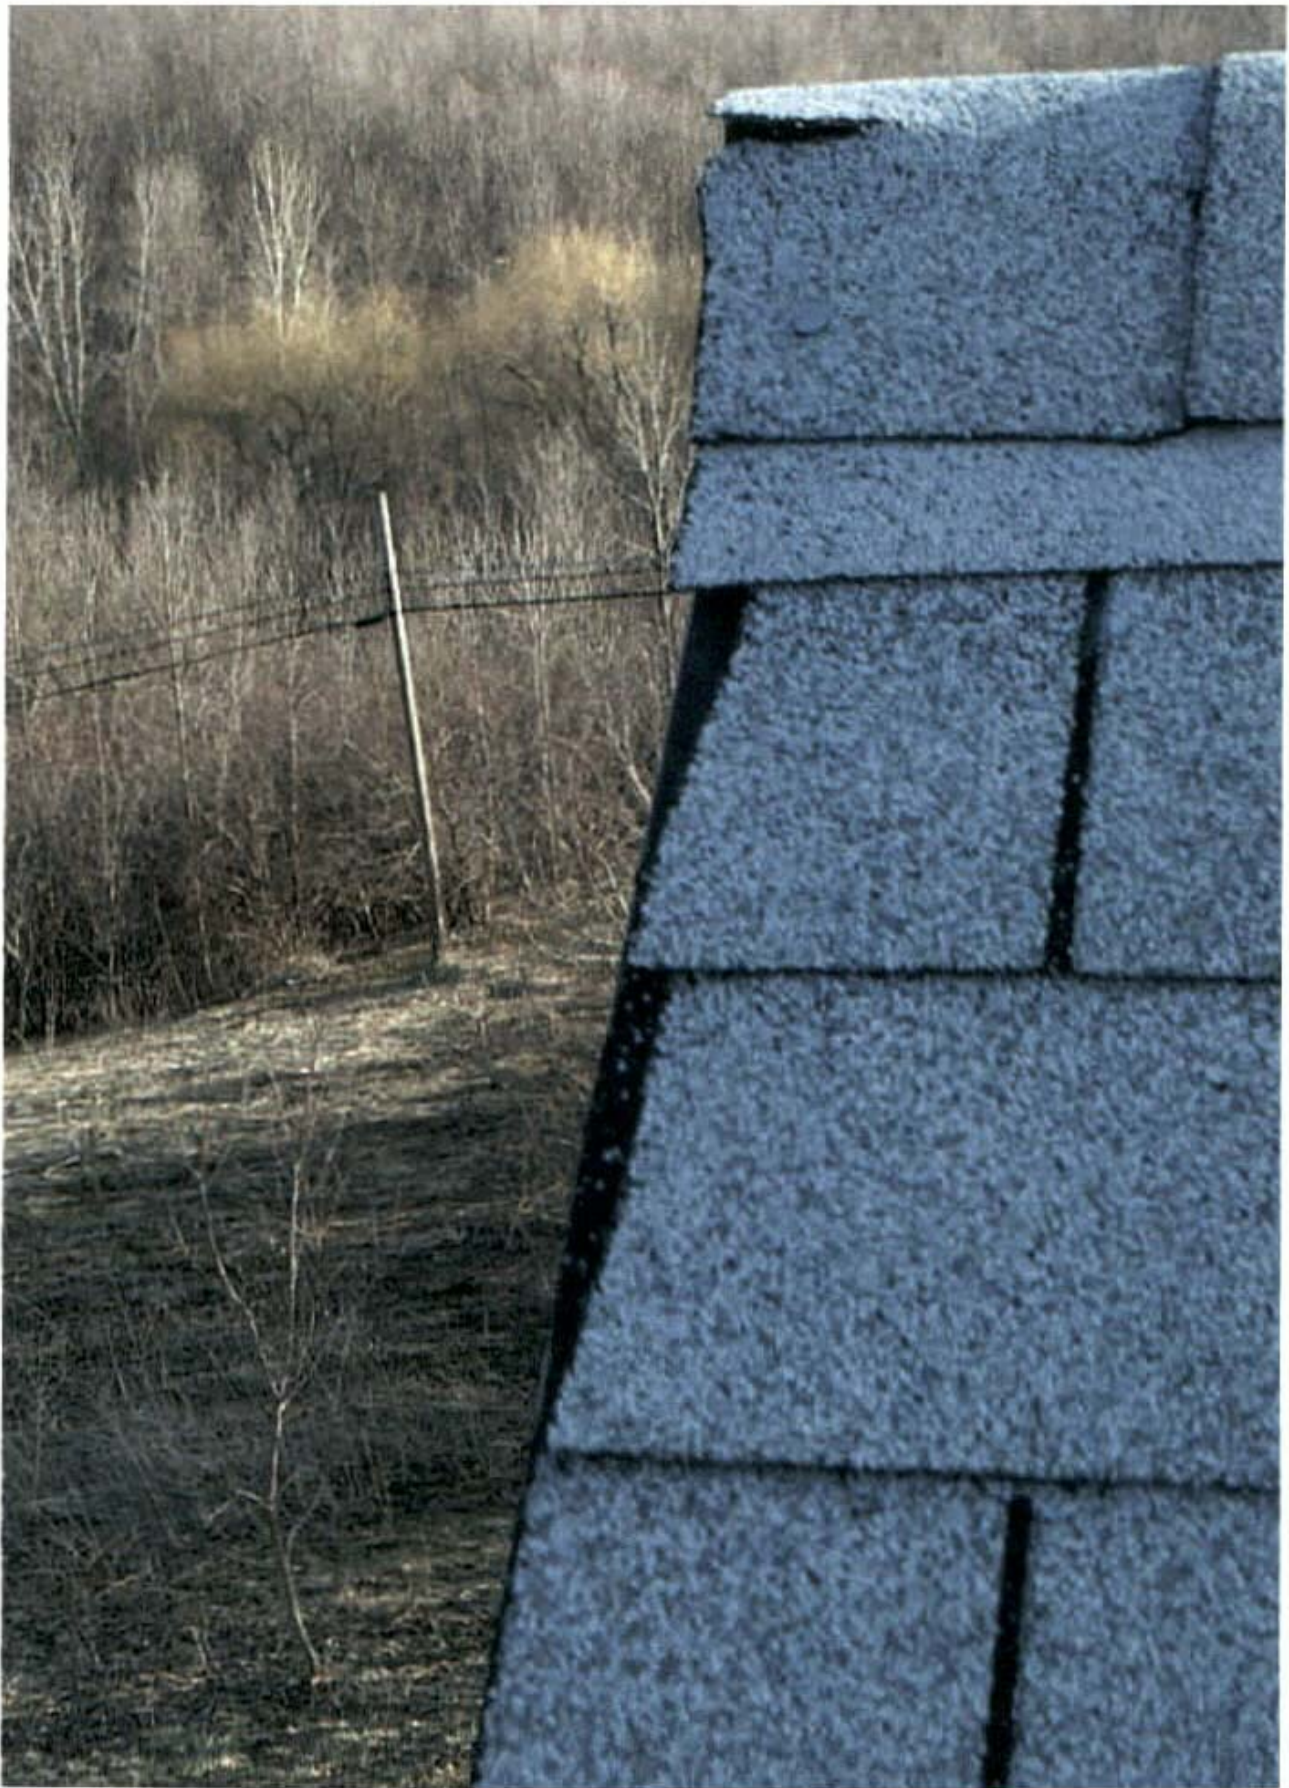
Jagged cuts on edge of roof; and a split ridge-cap right at the top of the peak (Photo by Professional Home Inspection Services)

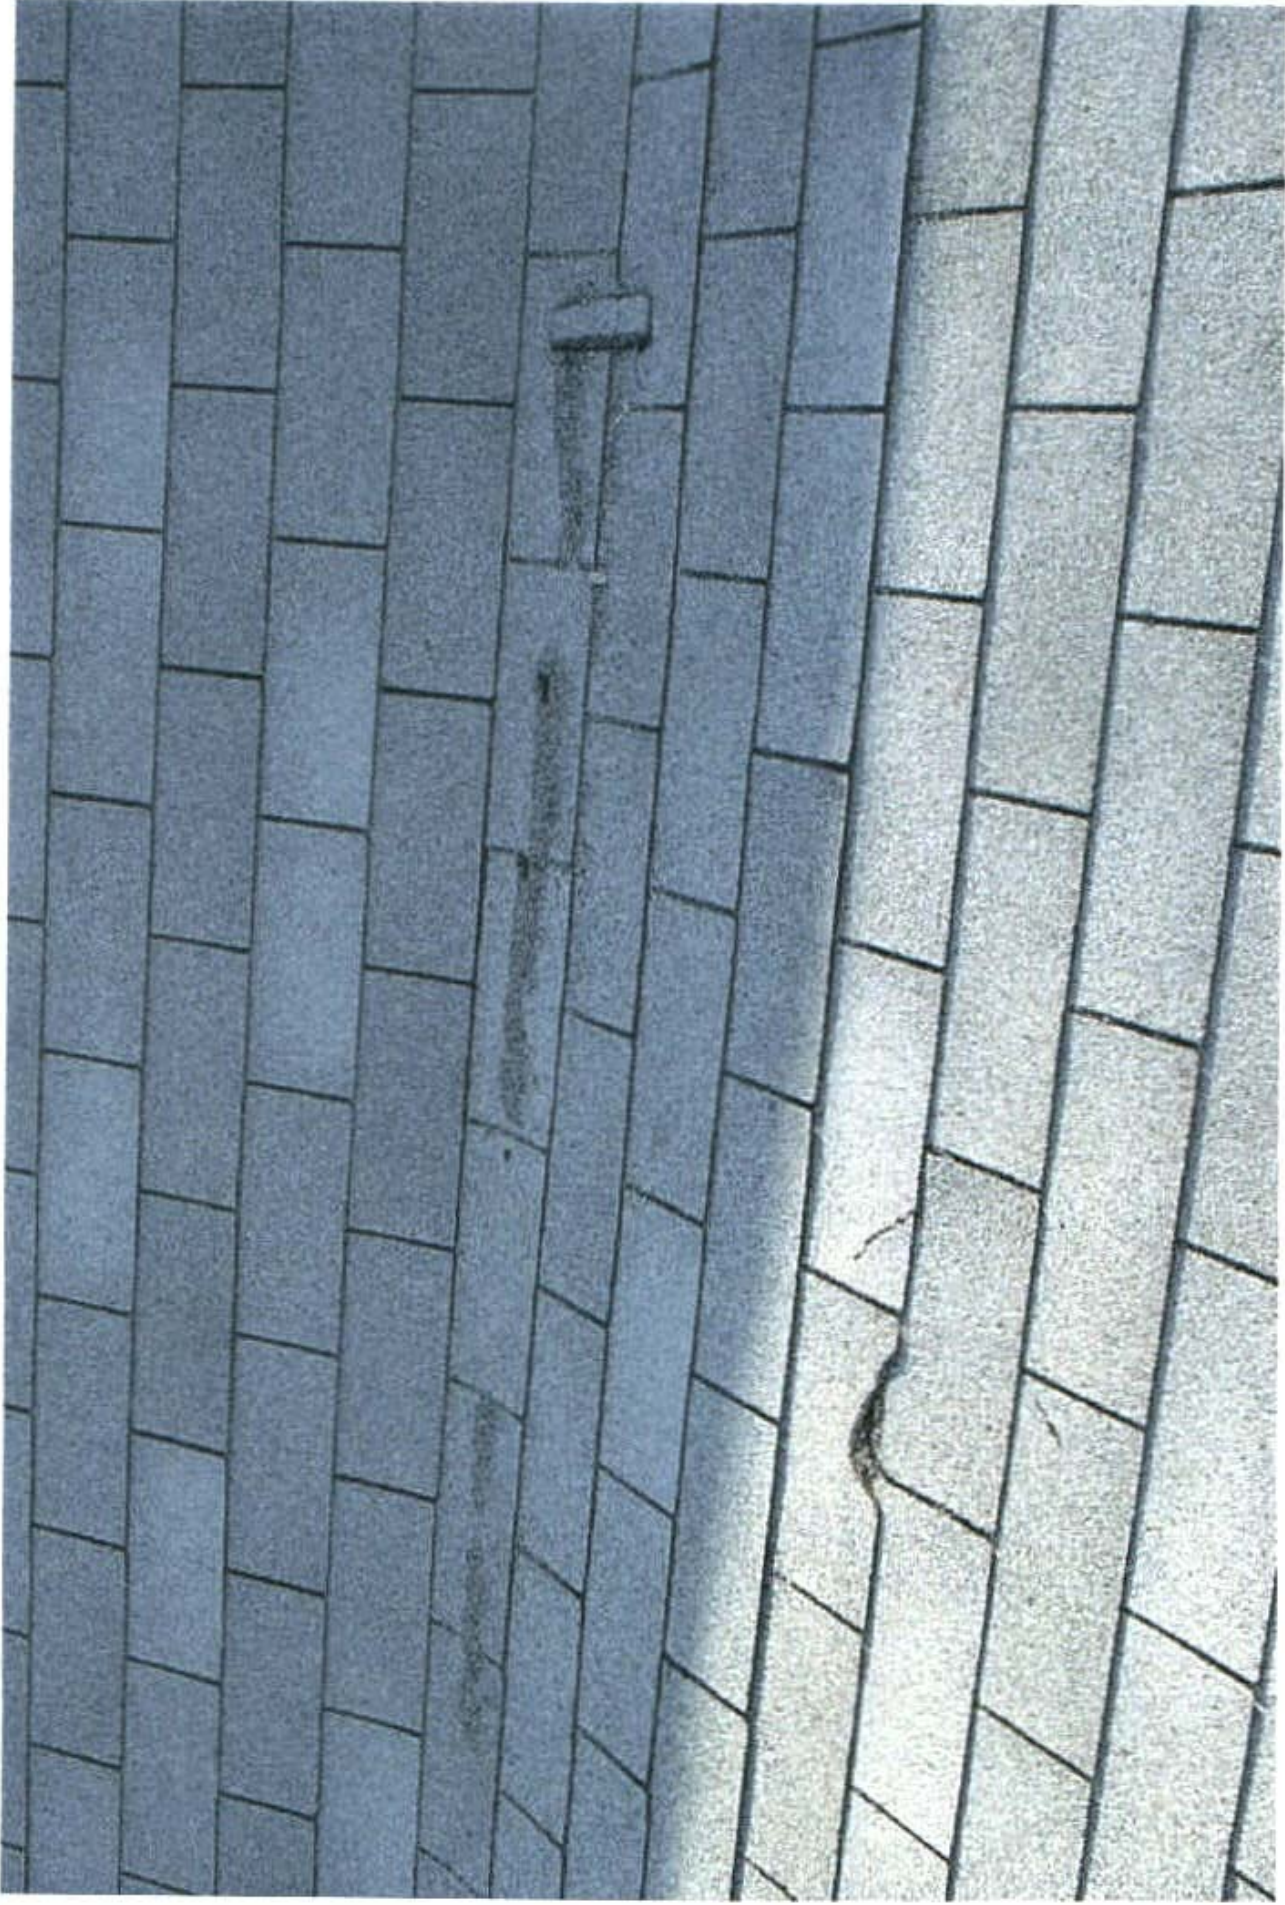
Gouged shingles and the crew left behind some debris here. Also this area of the roof shouldn't be shingled at all. The NYS Building Code dictates that shingles can only be used on steeper slopes than this. GAF manufactures and recommends a special membrane for this low-sloped area. (Photo by Professional Home Inspection Services)

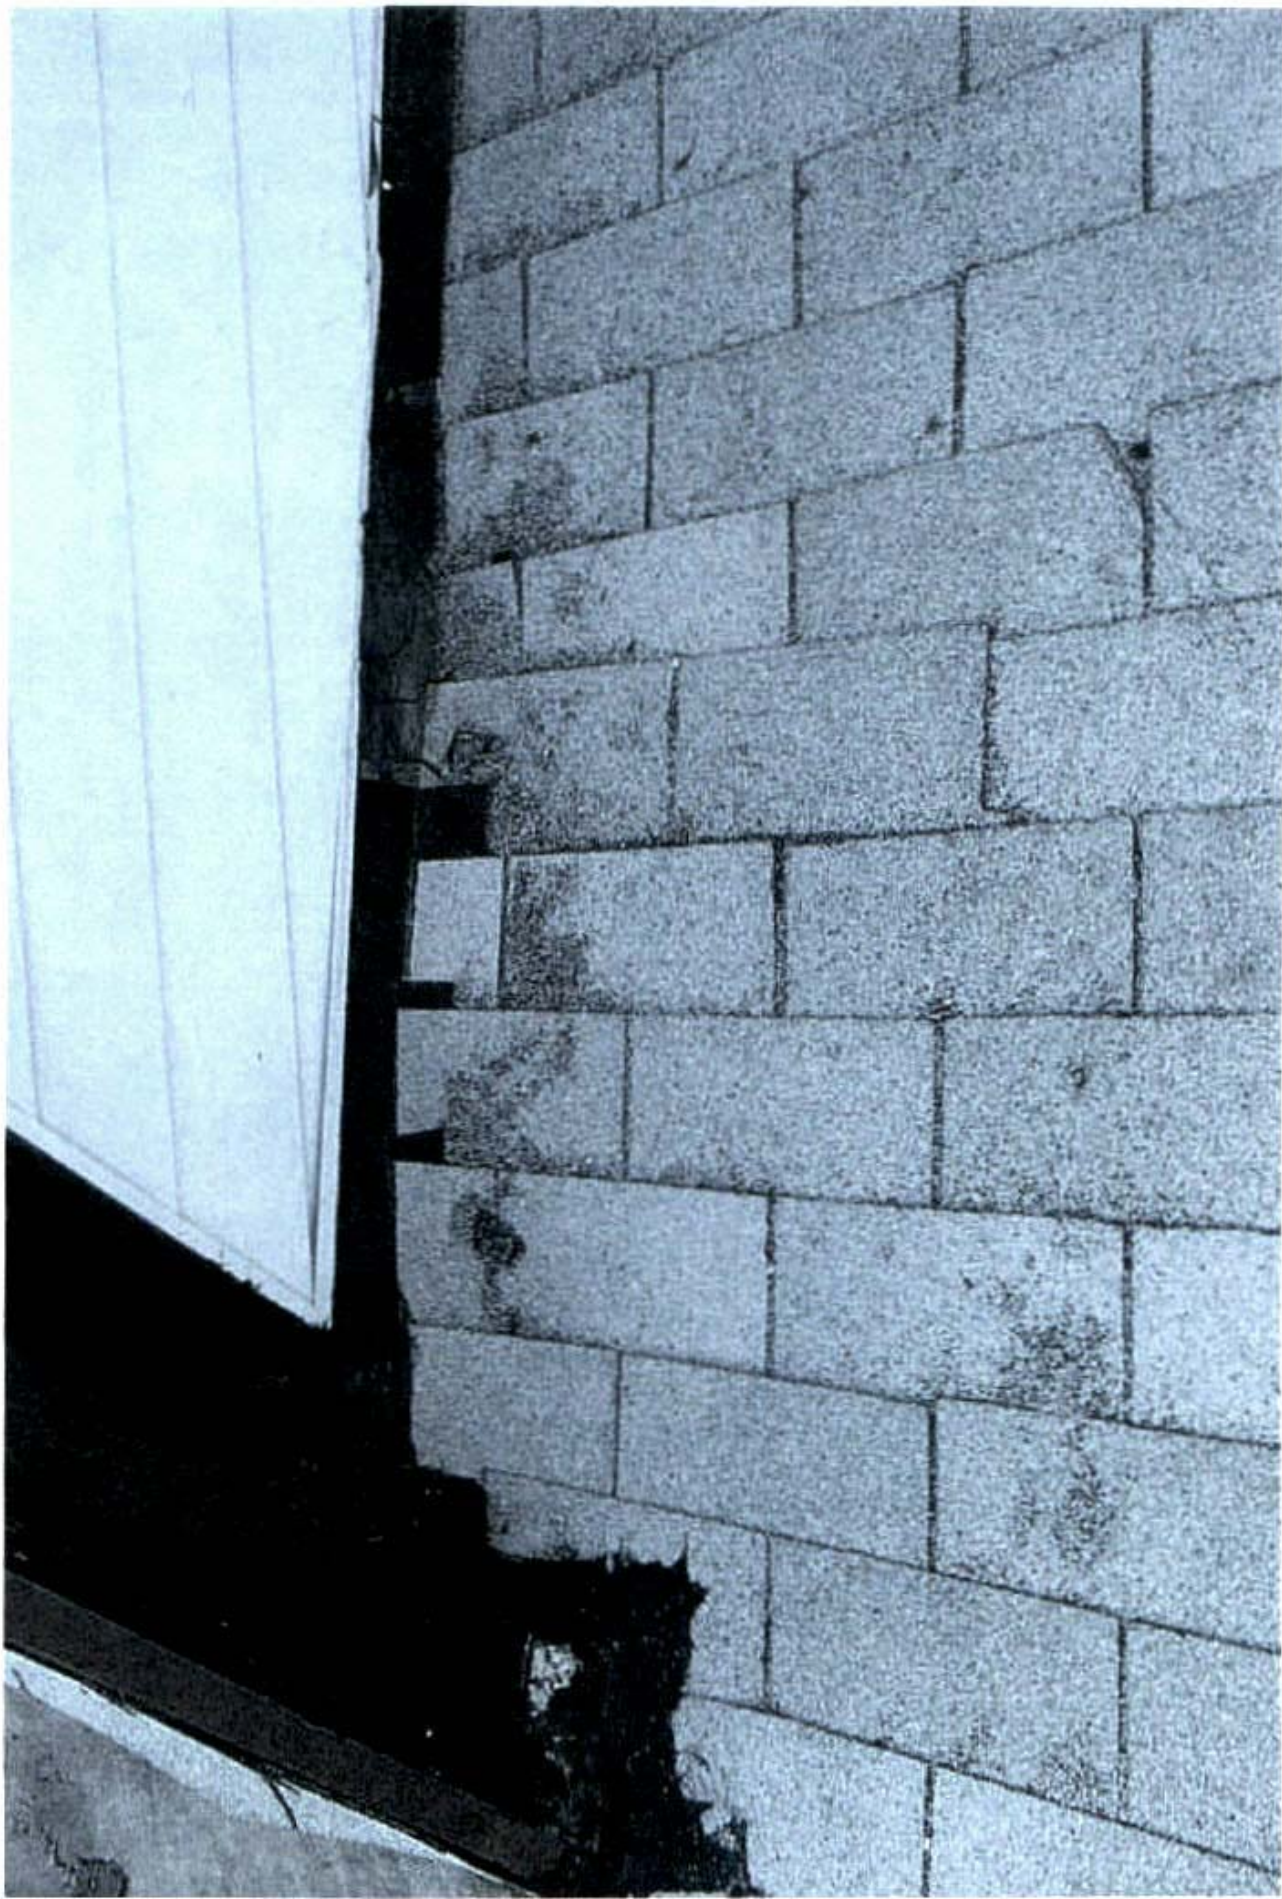
Sloppy work, use of tar instead of required new flashing, poor line up of shingles, and another gouged shingle (Photo by Professional Home Inspection Services)

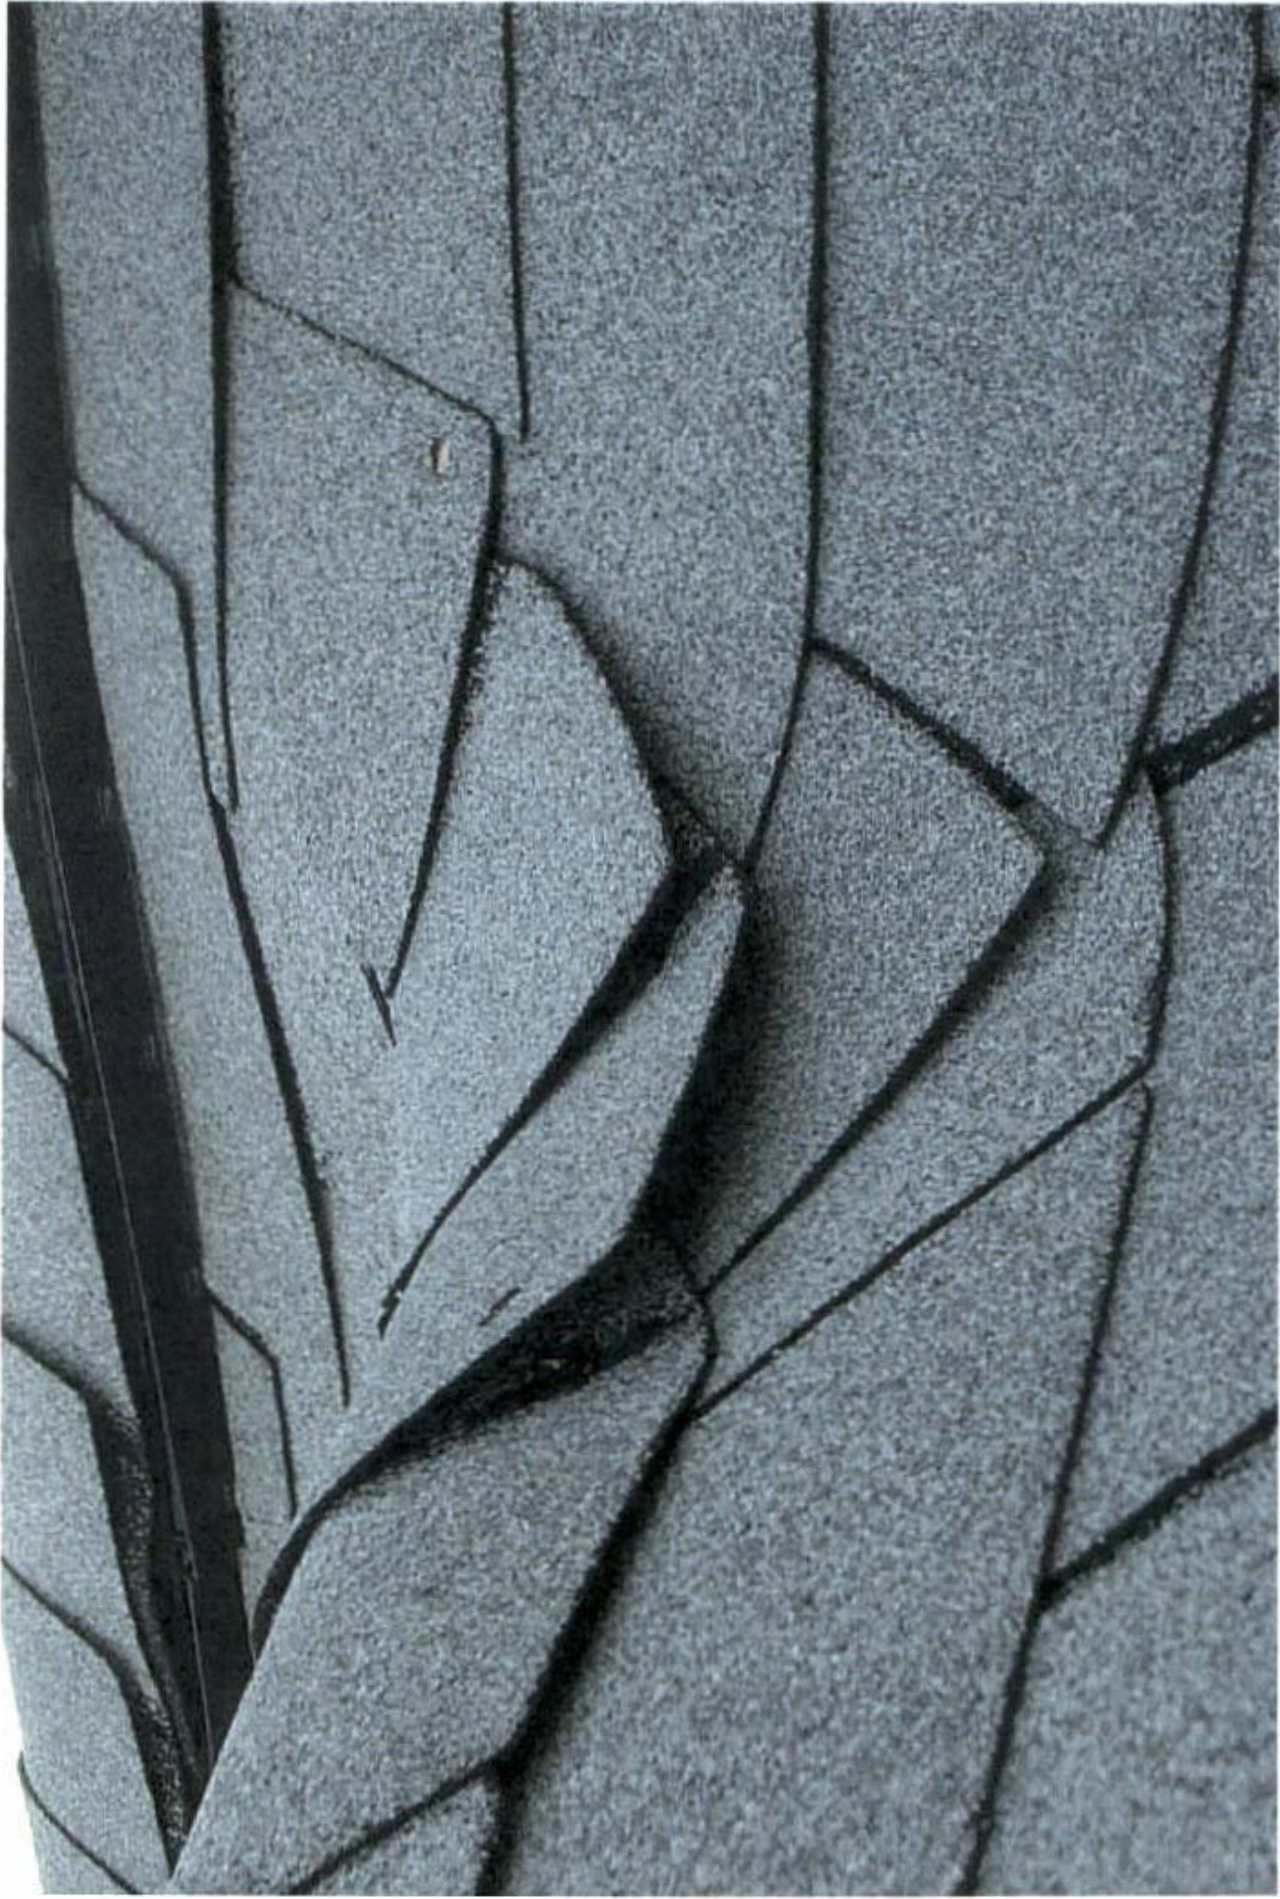
Loose ridge-caps. The crew used too much pressure in their nail guns and drove the nails right through many, many shingles (Photo by Professional Home Inspection Services)

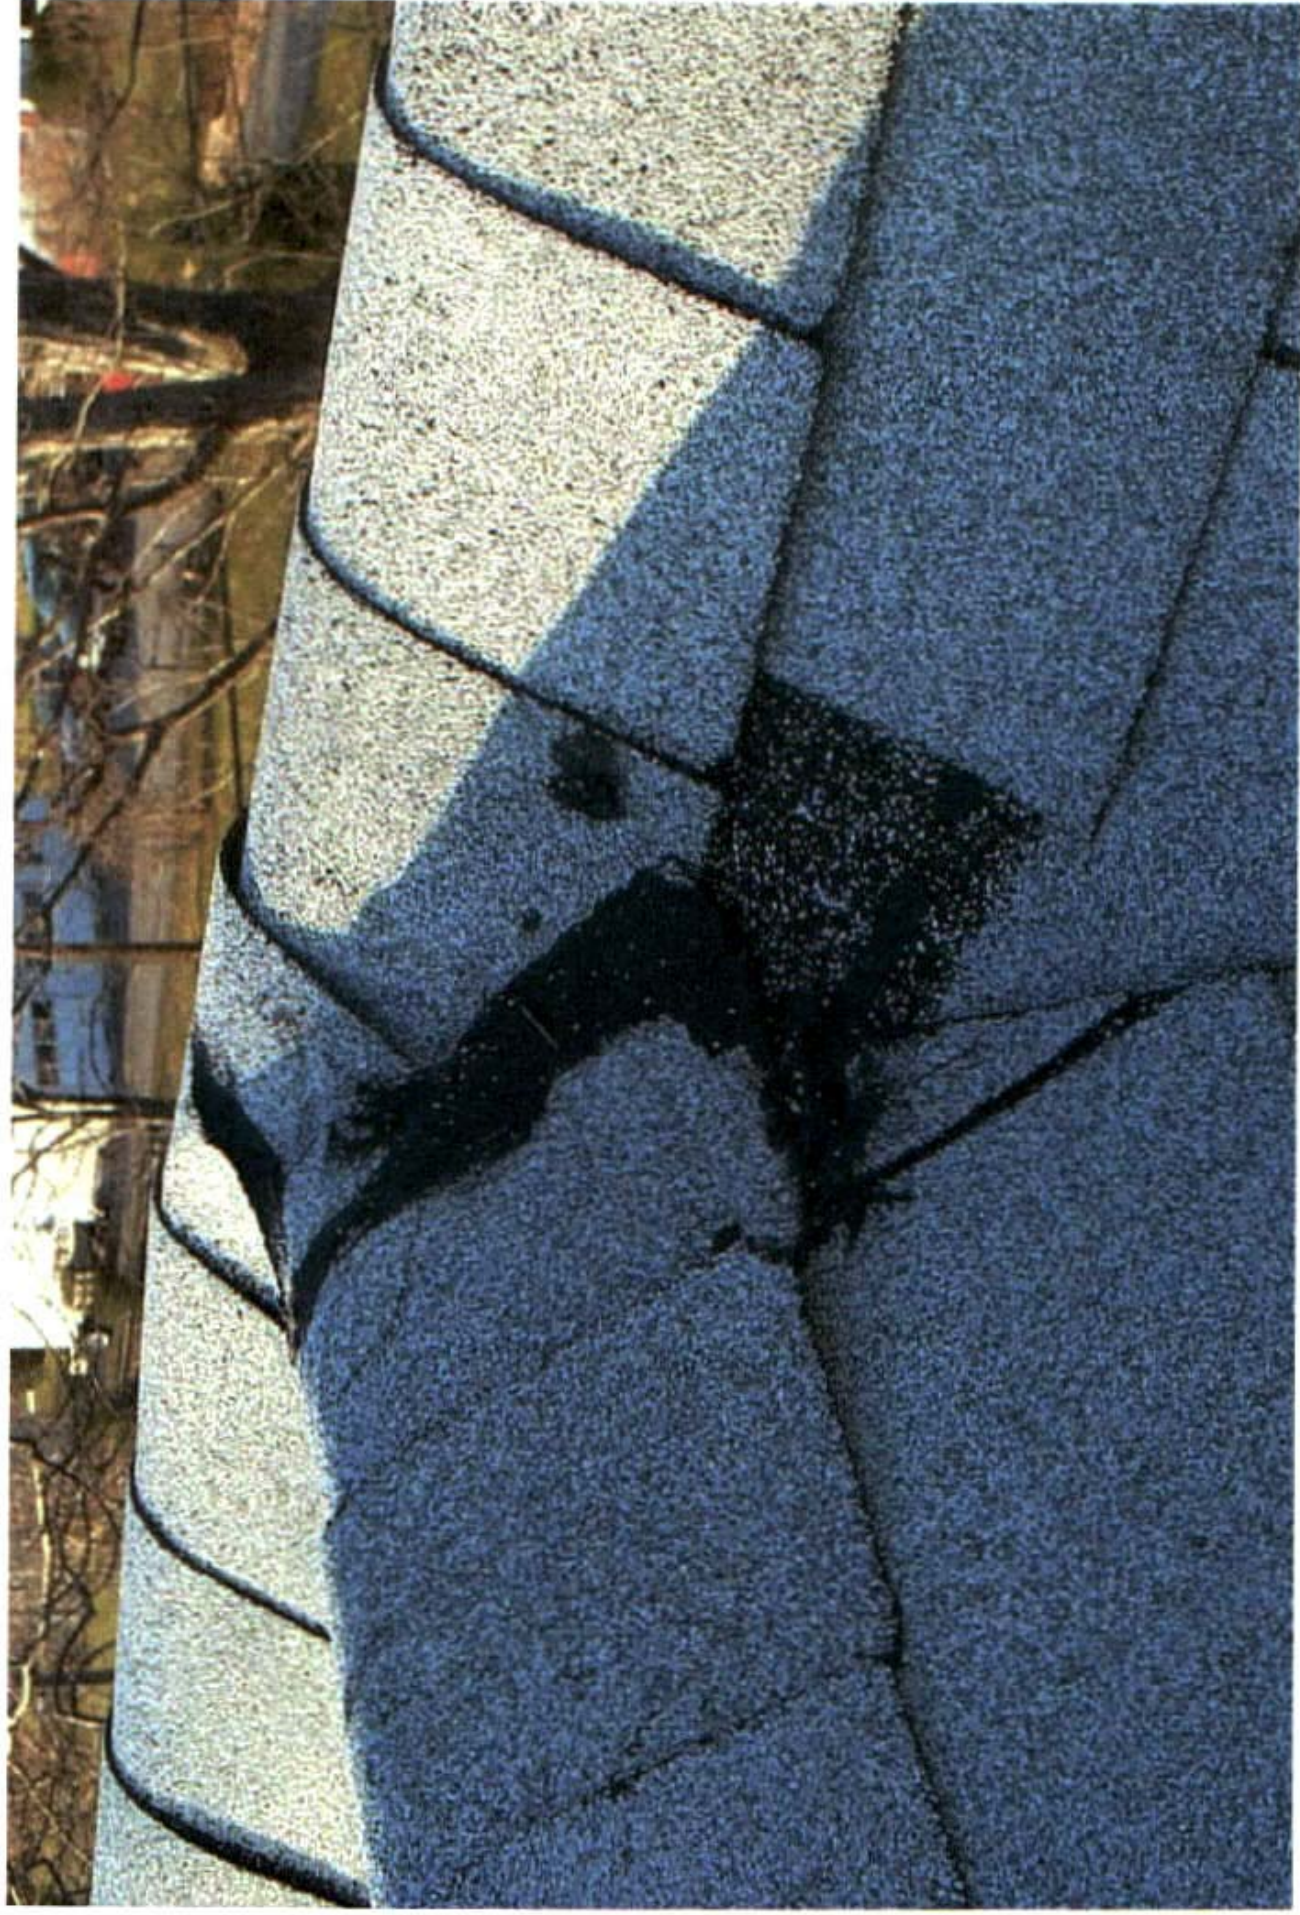
More loose ridge-caps, lack of shingles, and use of tar (Photo by Professional Home Inspection Services)

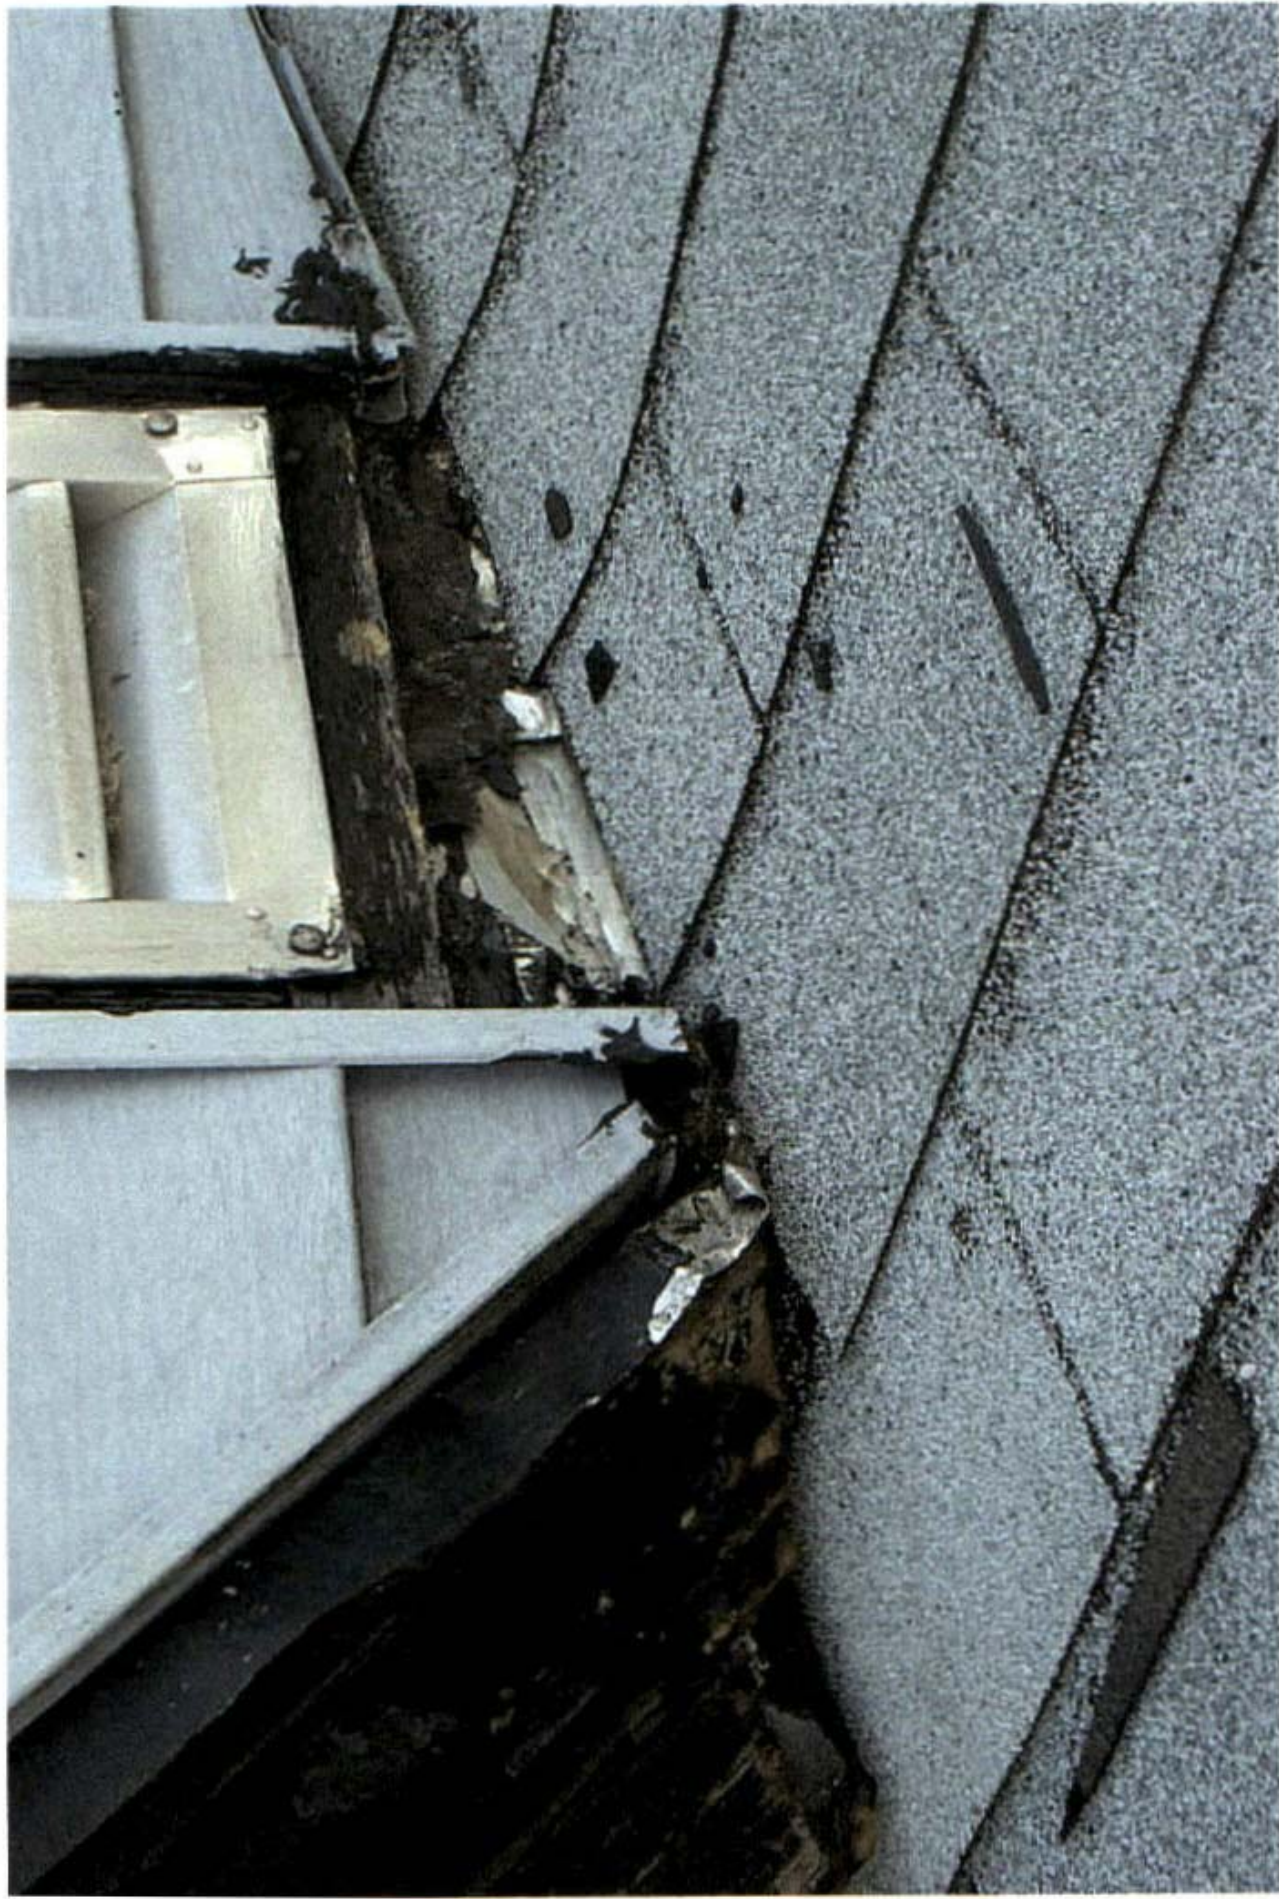
More debris and the flashing was not replaced as required by NYS code (Photo by Professional Home Inspection Services)

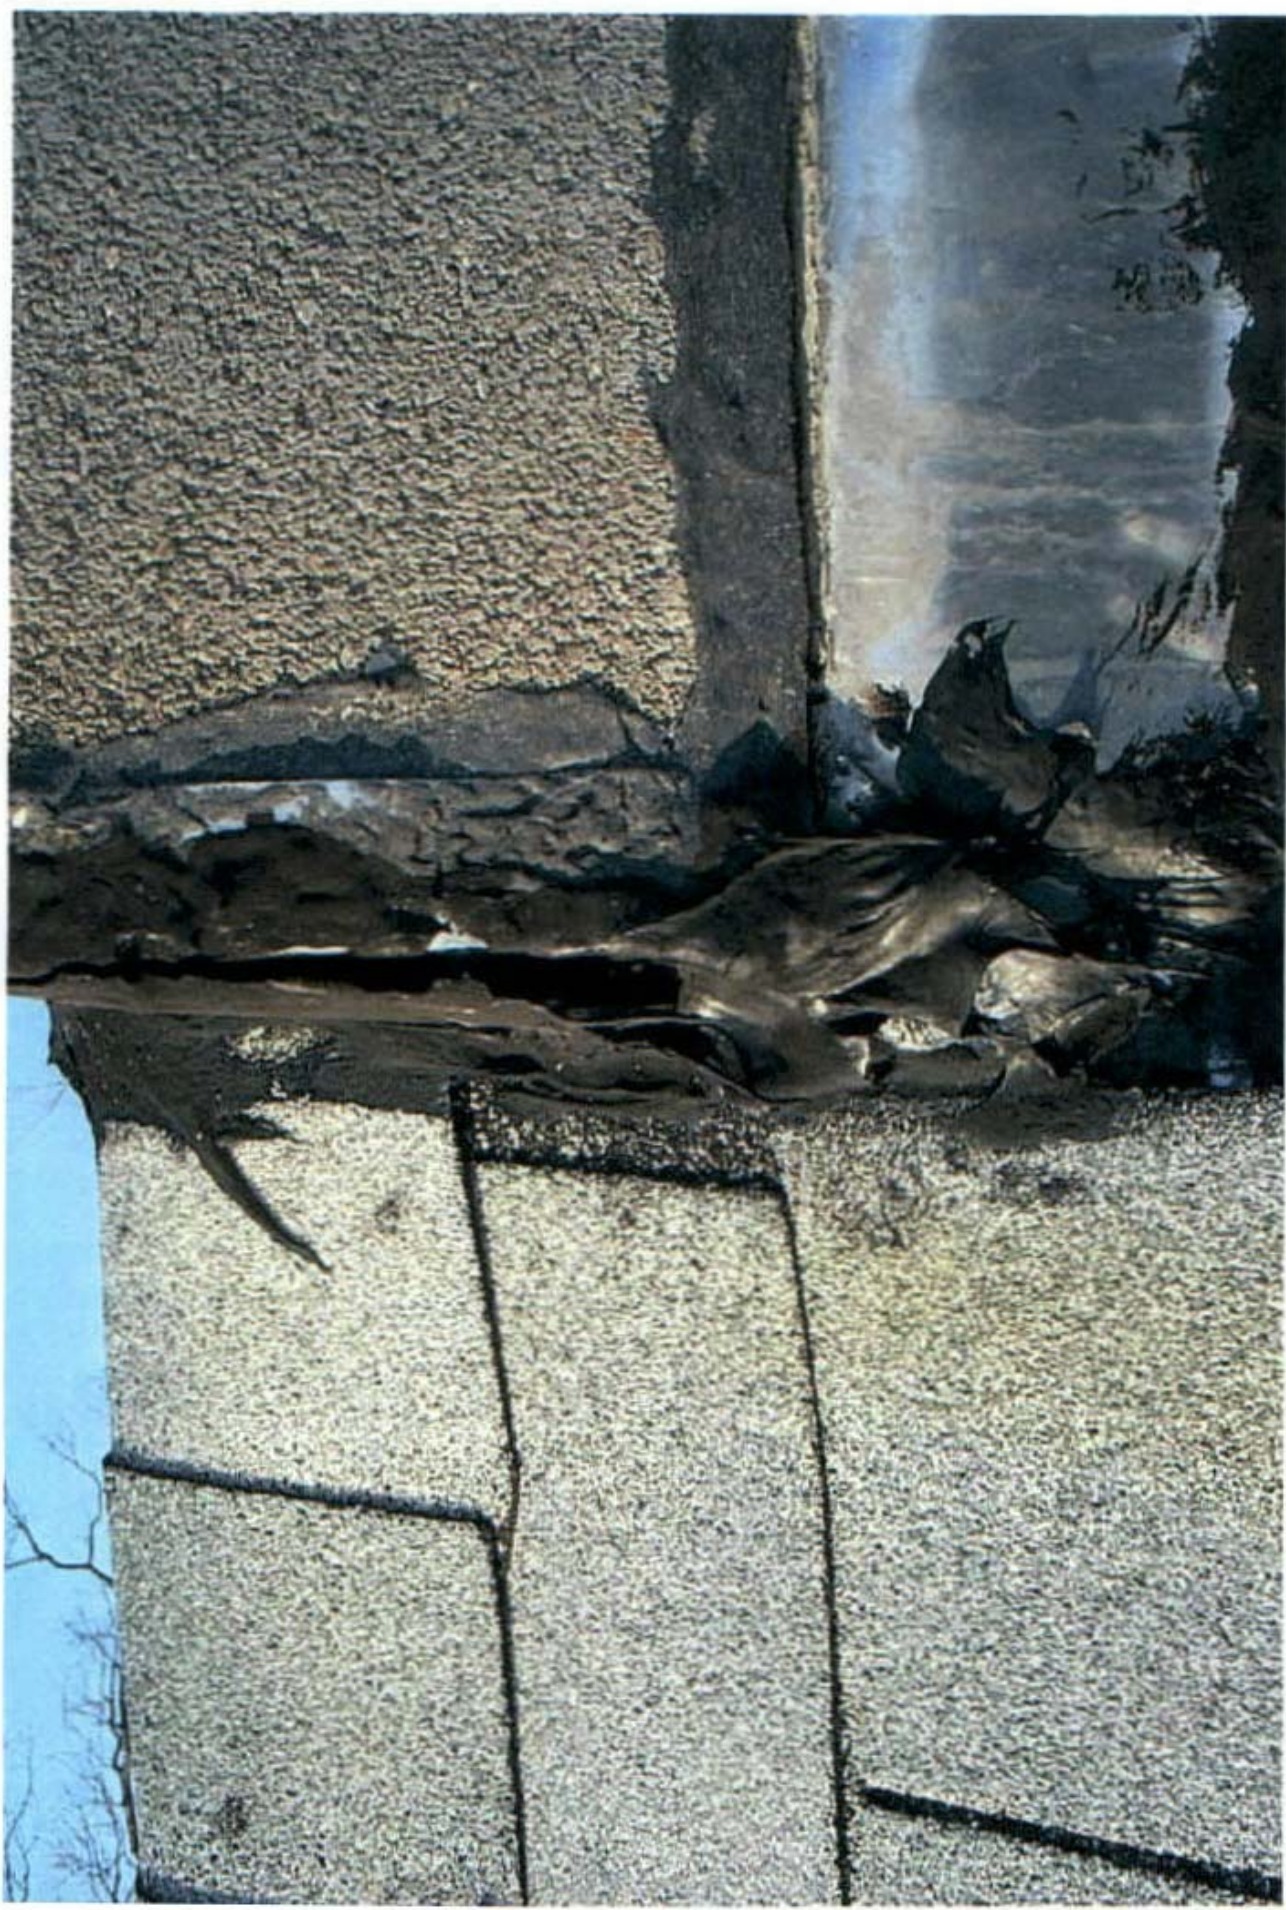
The crew used gobs of tar instead of required new flashing Notice the split in the old flashing – where the tar is leaking out. (Photo by Professional Home Inspection Services)
