# Roofing Infractions

RE: Inspection of ***GAF Materials Corporation*** Roofing System

As per your request, I inspected a GAF Roofing System at the residence located at 17029 Gulf Road, Holley, NY on March 29, 2004. This letter is to document my findings.

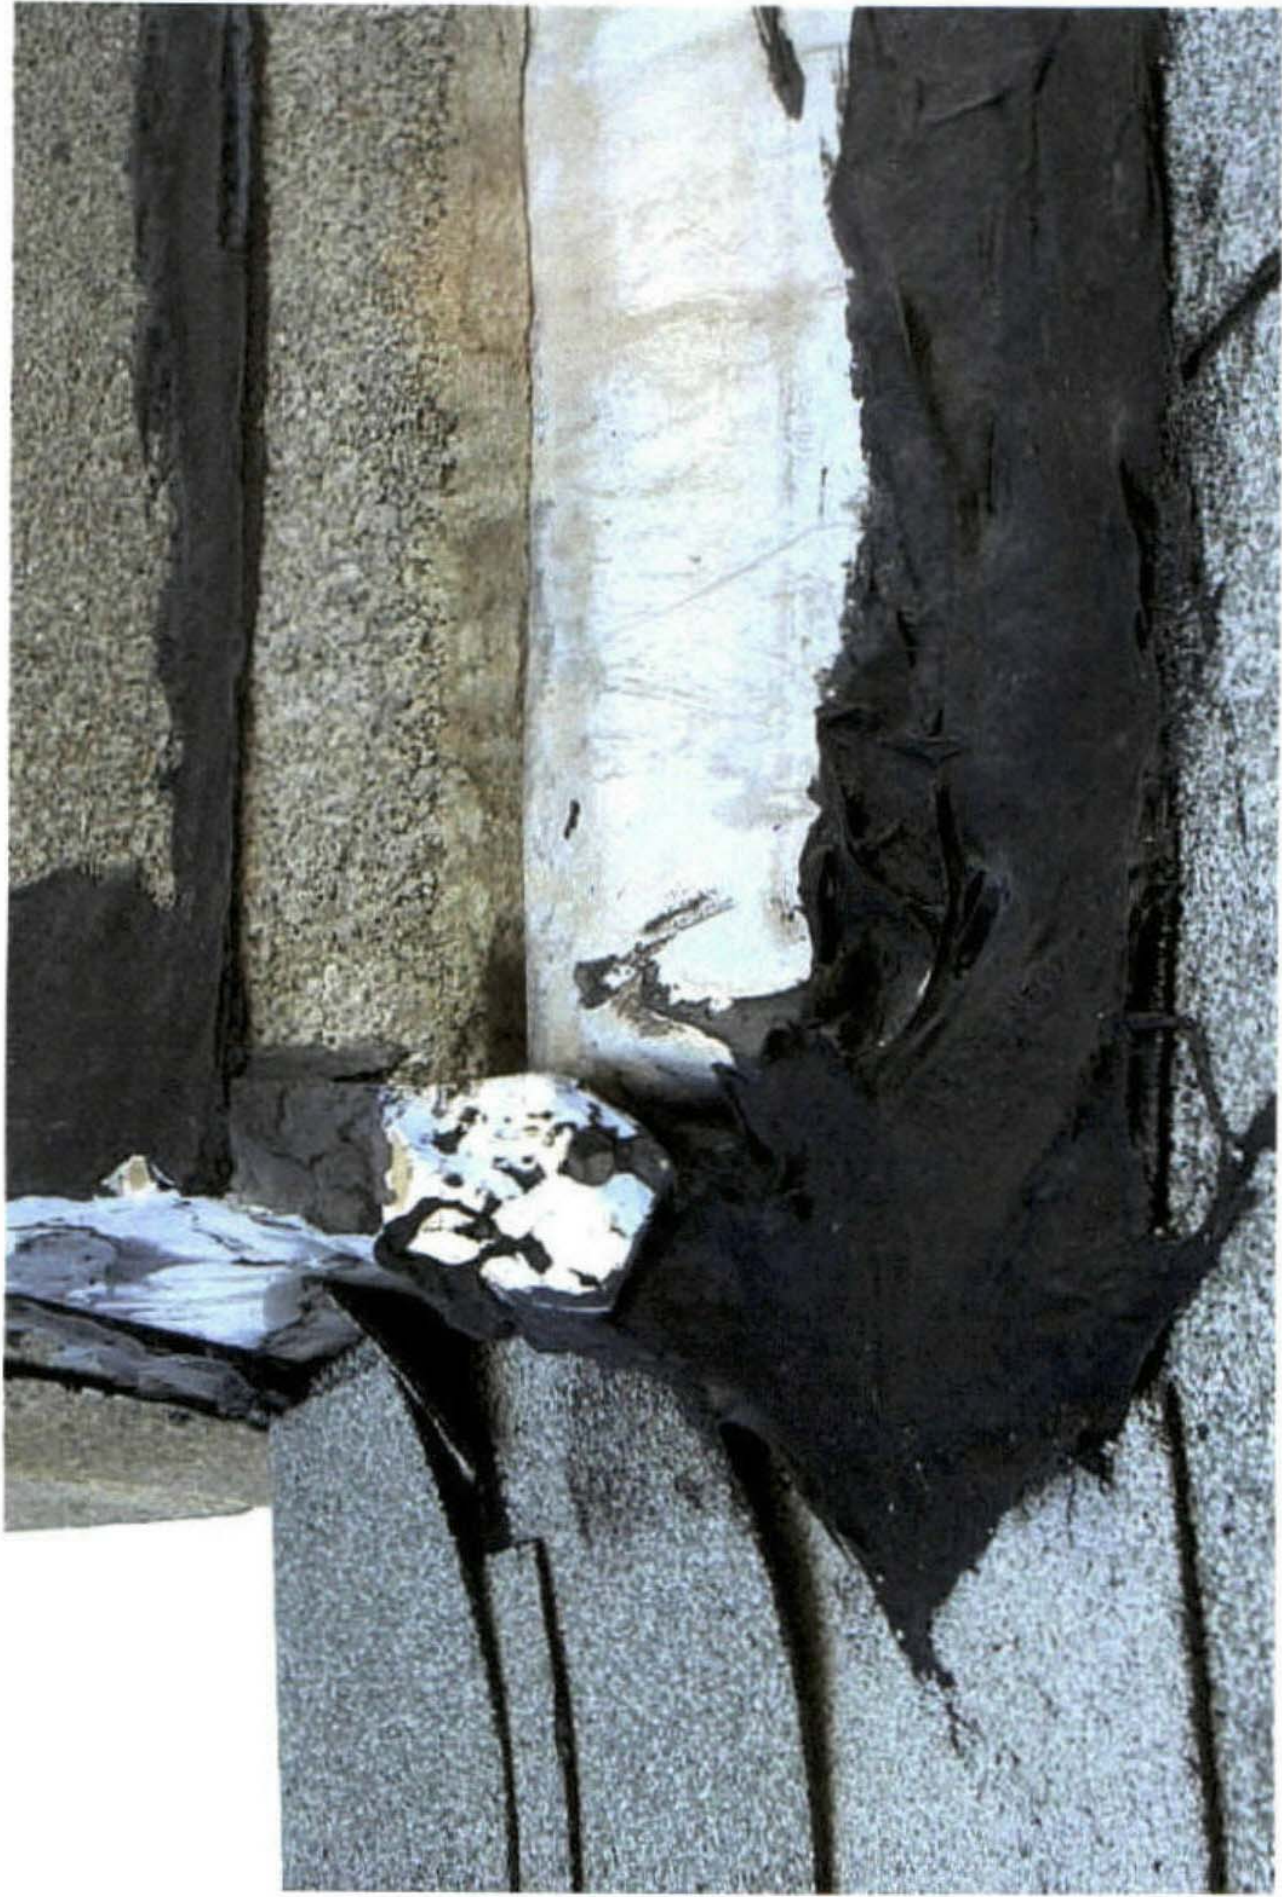
Shows use of gobs of tar and poor placement of one shingle. Note the tar is on top of the shingles  
(Photo by Professional Home Inspection Services)

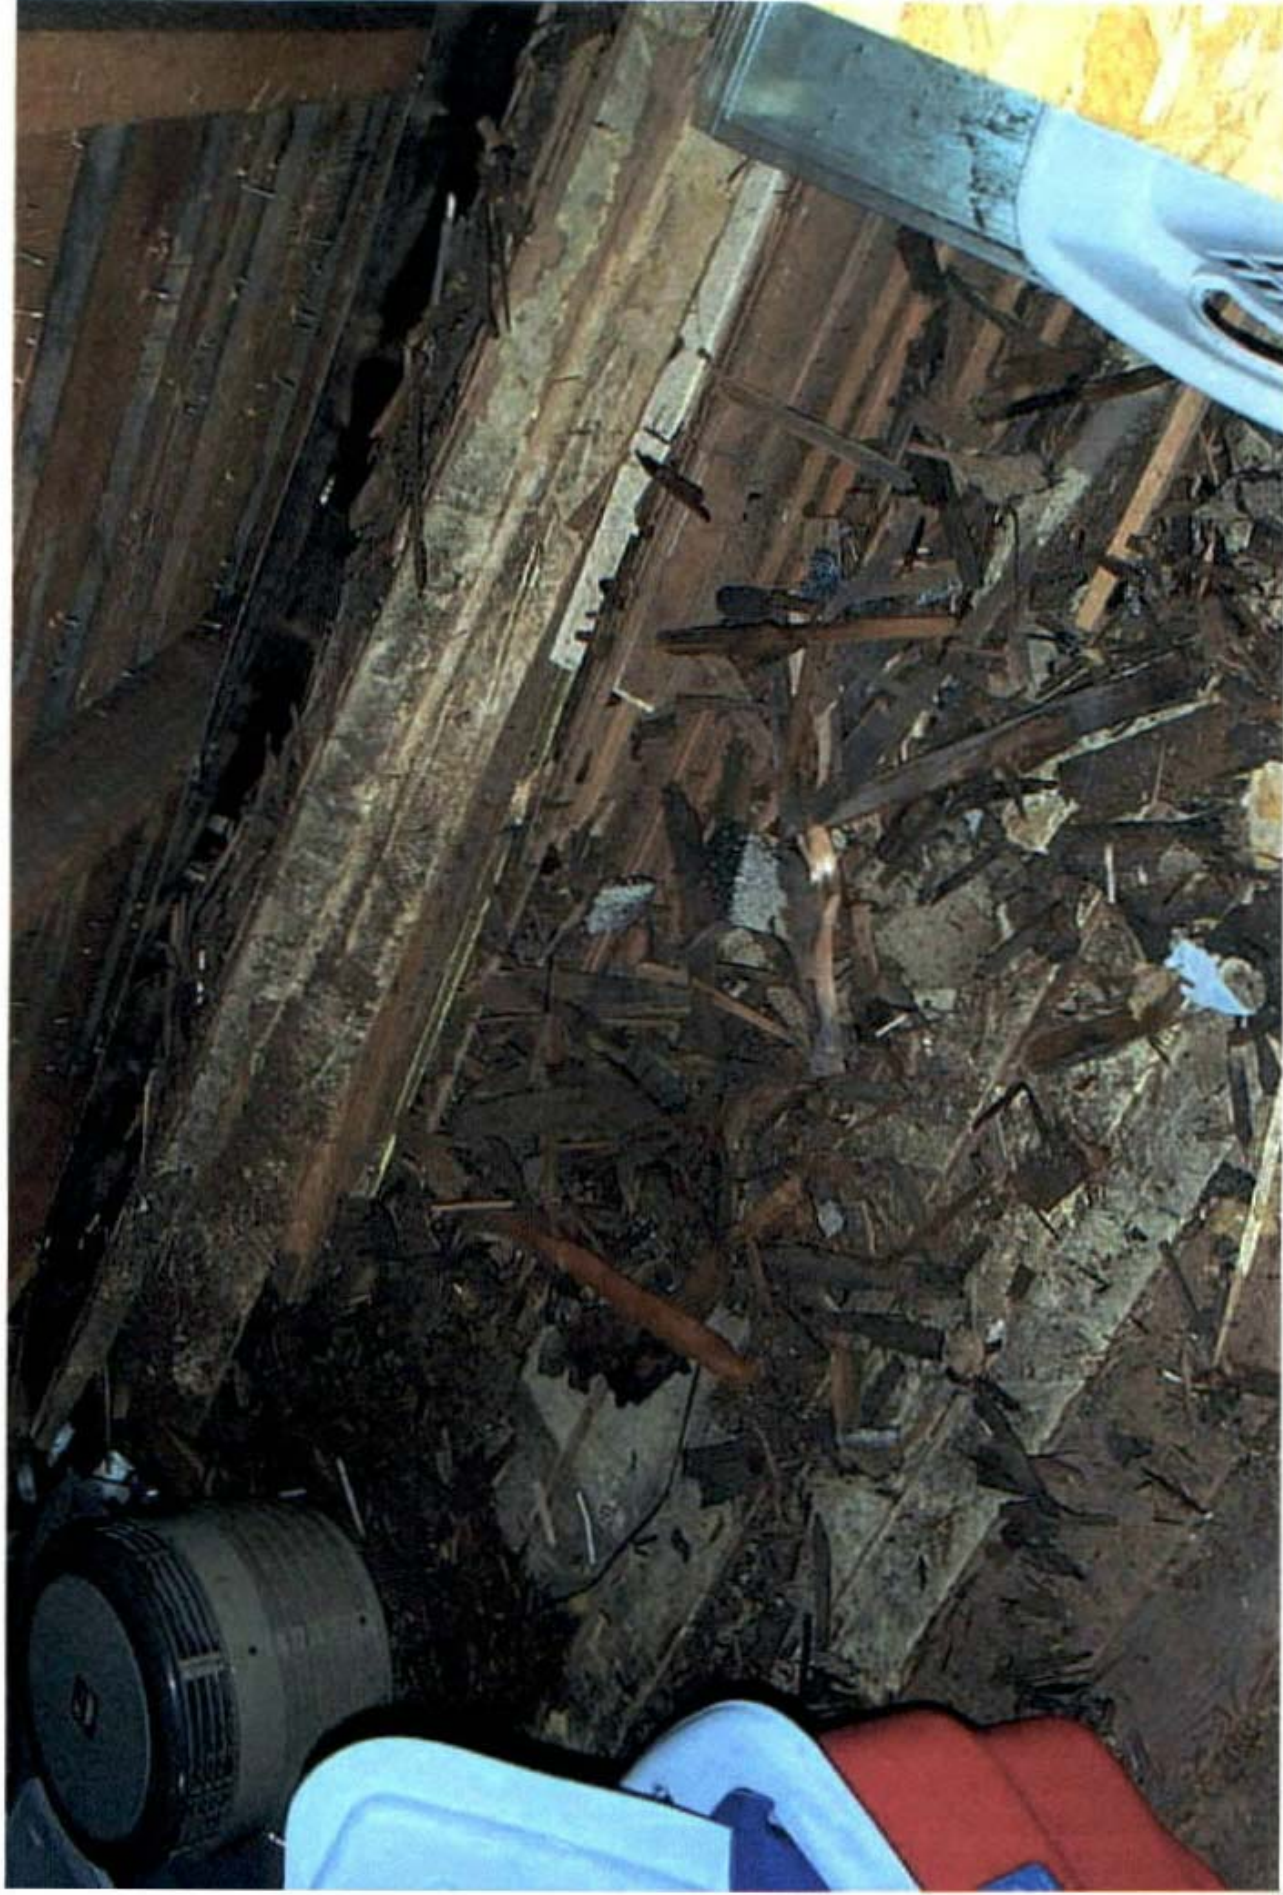
Here is a little of the debris that was left in the attic. They left several wastebaskets full of this dusty garbage for the homeowner to clean up. (Photo by Professional Home Inspection Services)

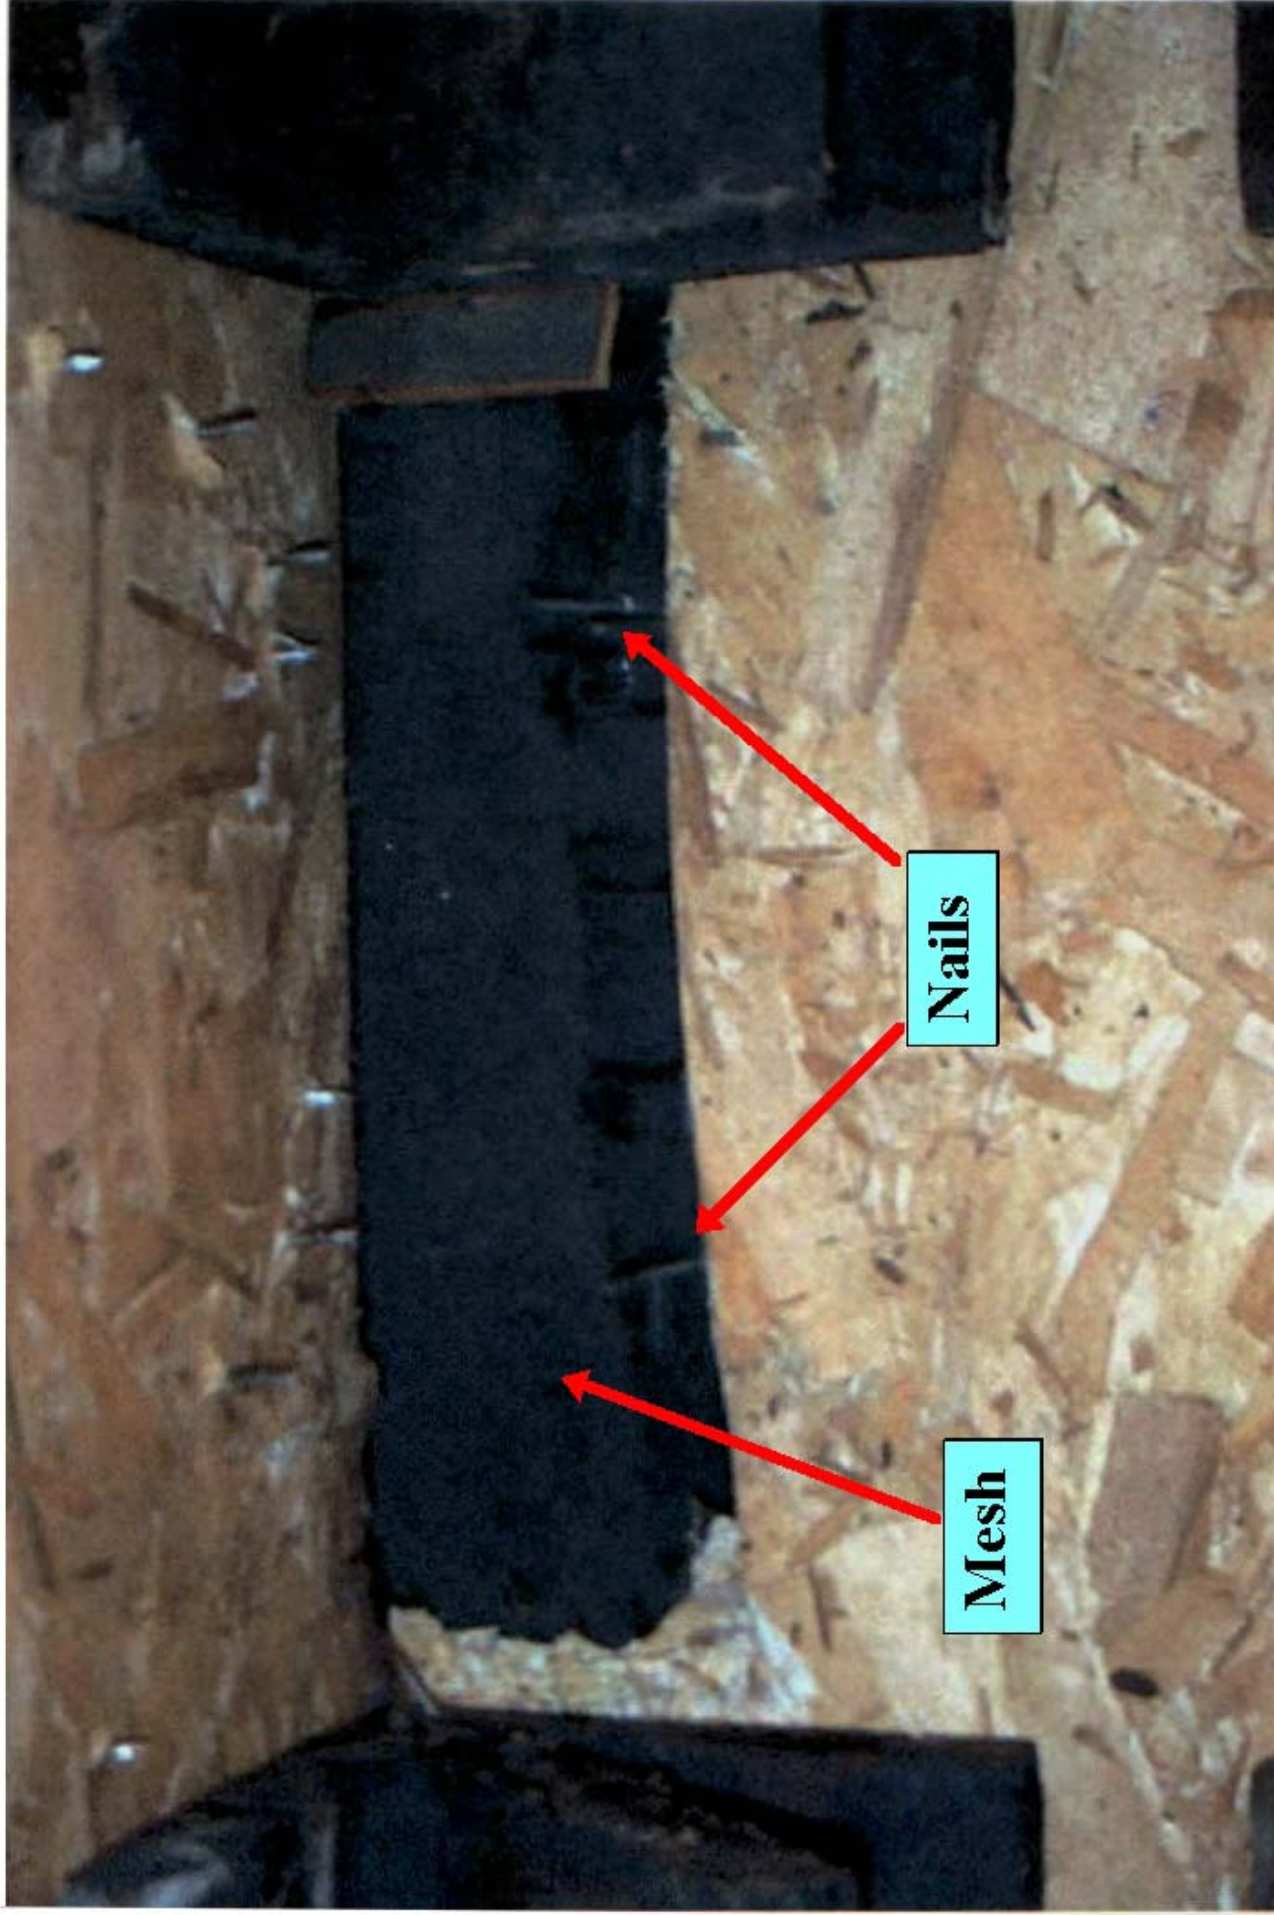
This shows a six-inch gouge in the Advantech plywood found at one small area at the peak of the attic. According to Manufacturer's specs, there is supposed to be a 1" cut on each side of the peak. Note that there are two nails that are driven into nothingness, and the filtering mesh fabric (gray area just above the nails) does not cover the aperture completely. (Photo by Professional Home Inspection Services)

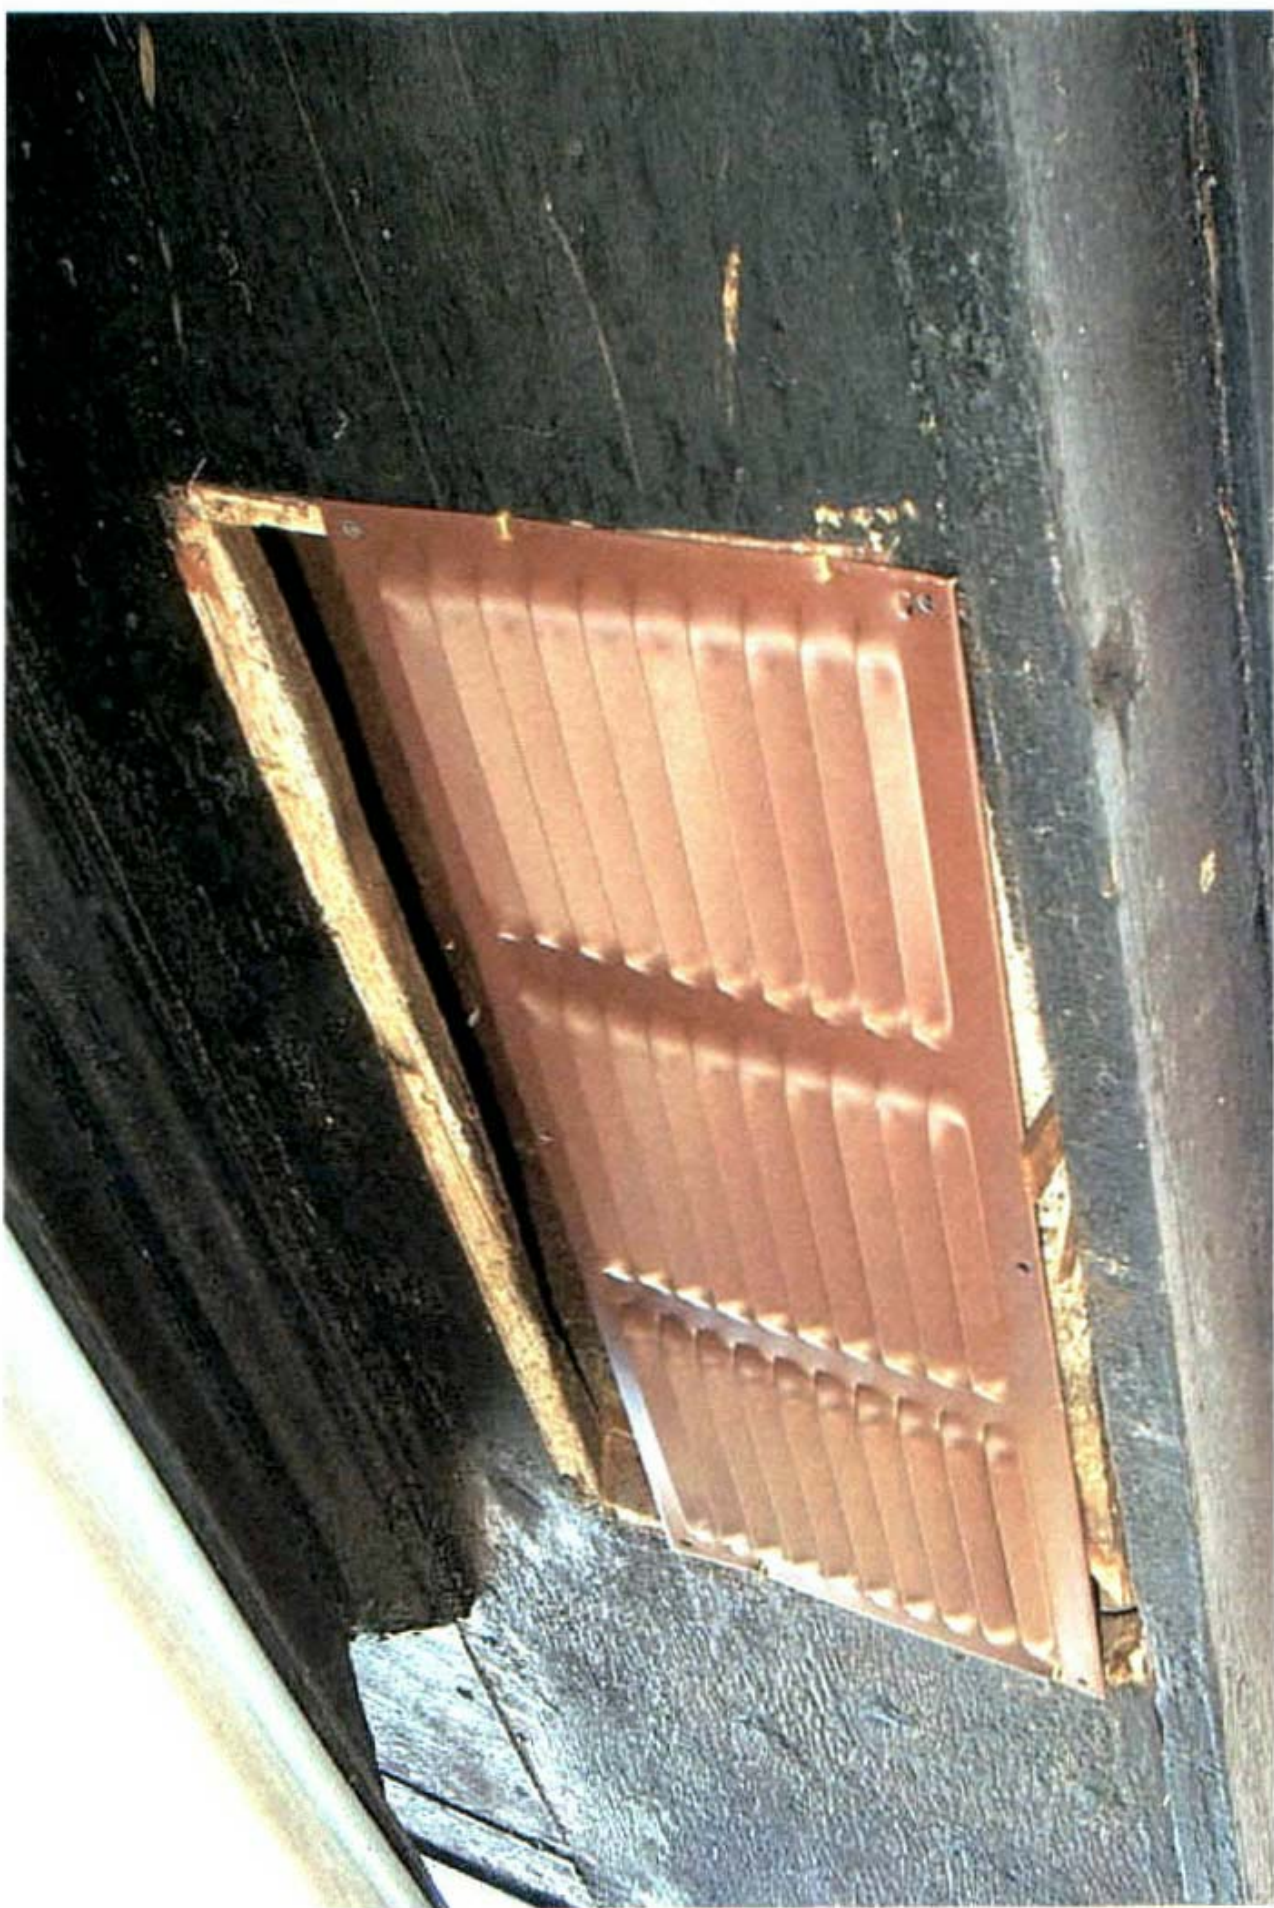
This shows how the crew installed a vent cover too small for the pre-existing hole. (Photo by Professional Home Inspection Services)

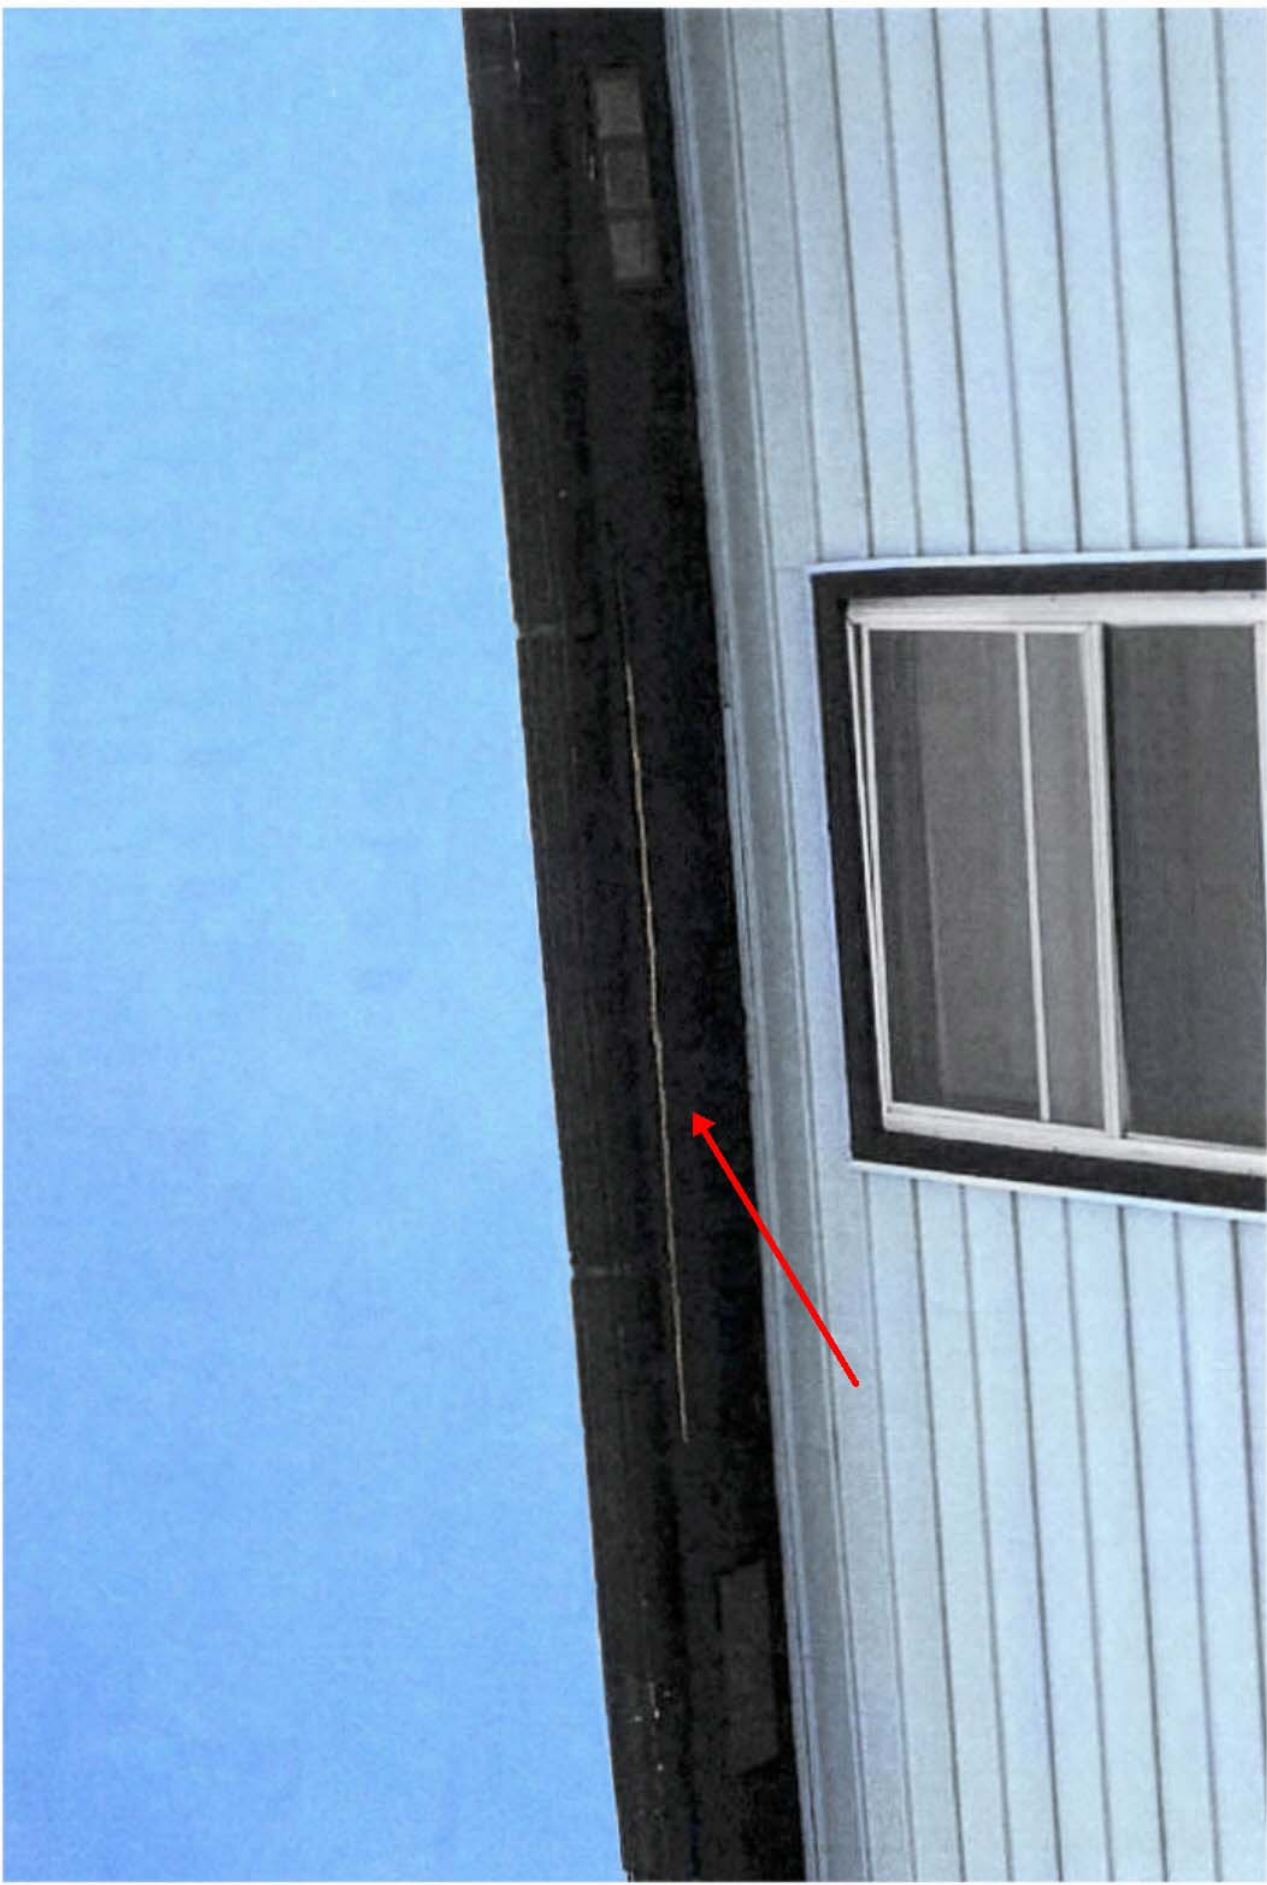
The lighter slice in the black shows where the leaking occurred from ice damming, and then the ice split open the eave. (Photo by Professional Home Inspection Services)

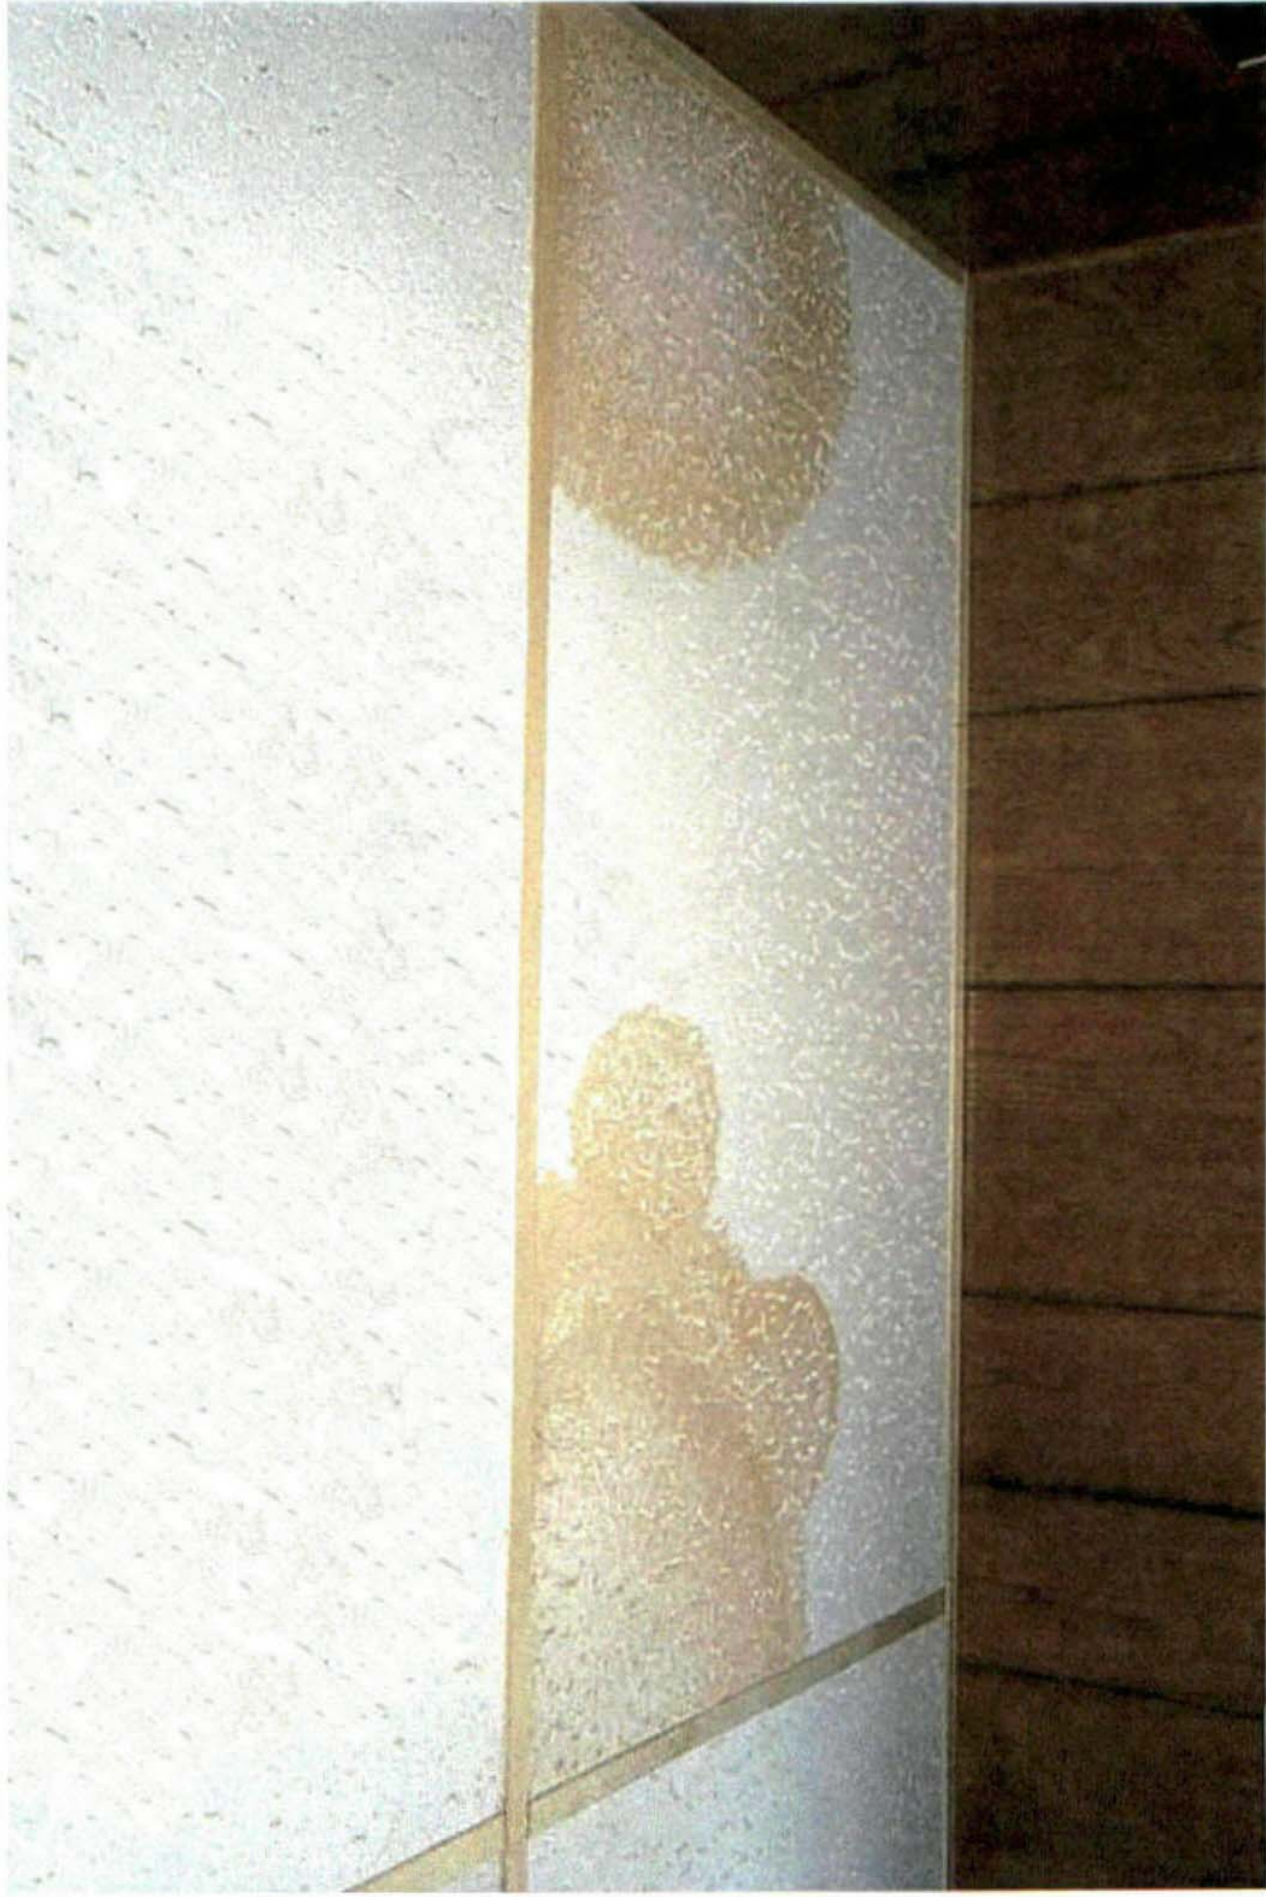
Water damage on one of the ceiling tiles from the same leak. The homeowner had already replaced the tile that became soaked through, and fell onto her tenant's brand-new bed. (Photo by Professional Home Inspection Services)

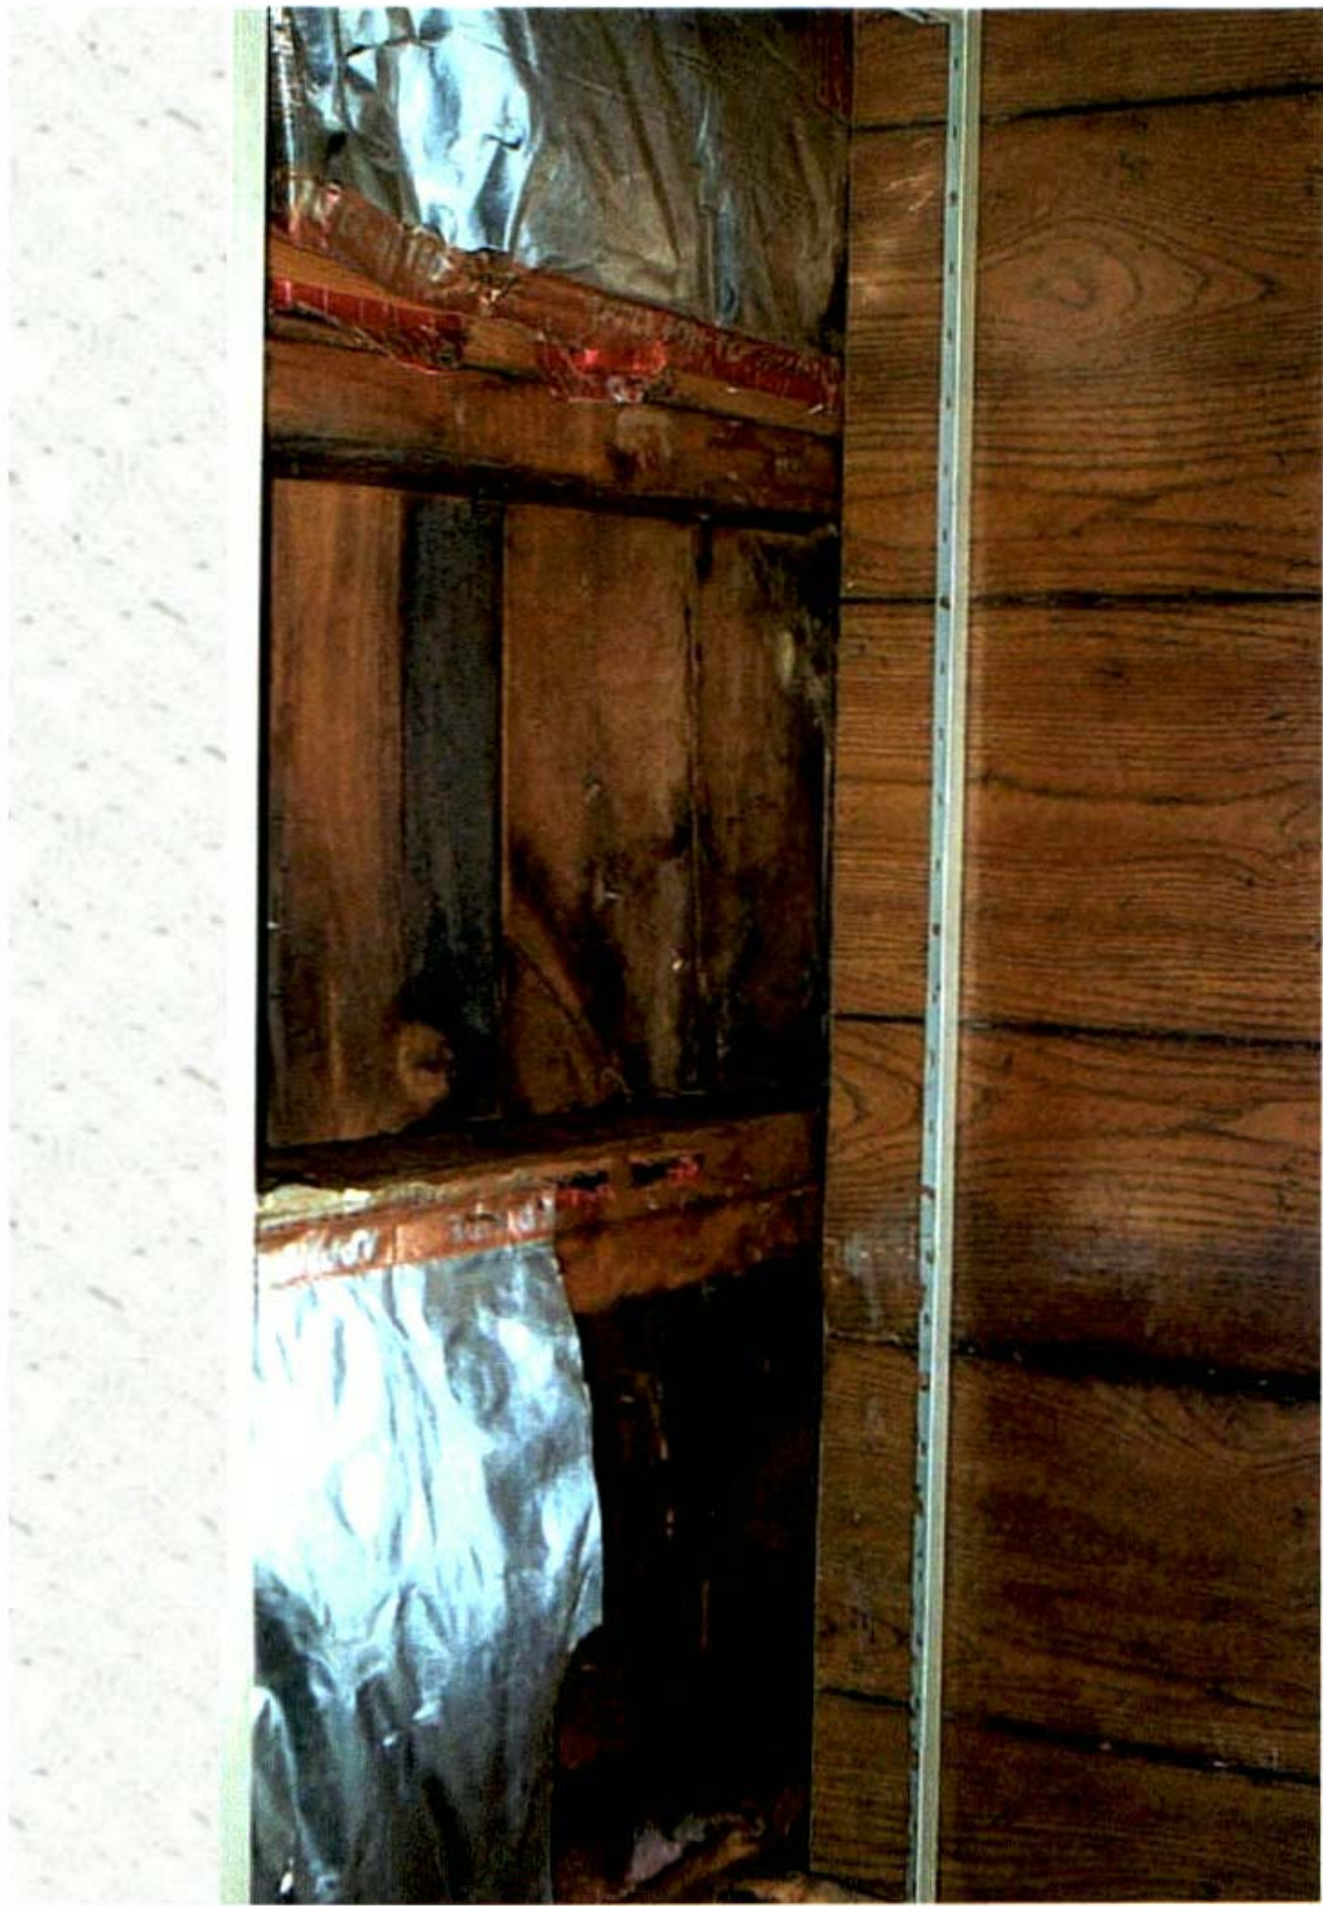
The contractor agreed to replace decking that was in poor condition; but this cracked, moldy wood reveals that they neglected to do so. (Photo by Professional Home Inspection Services)

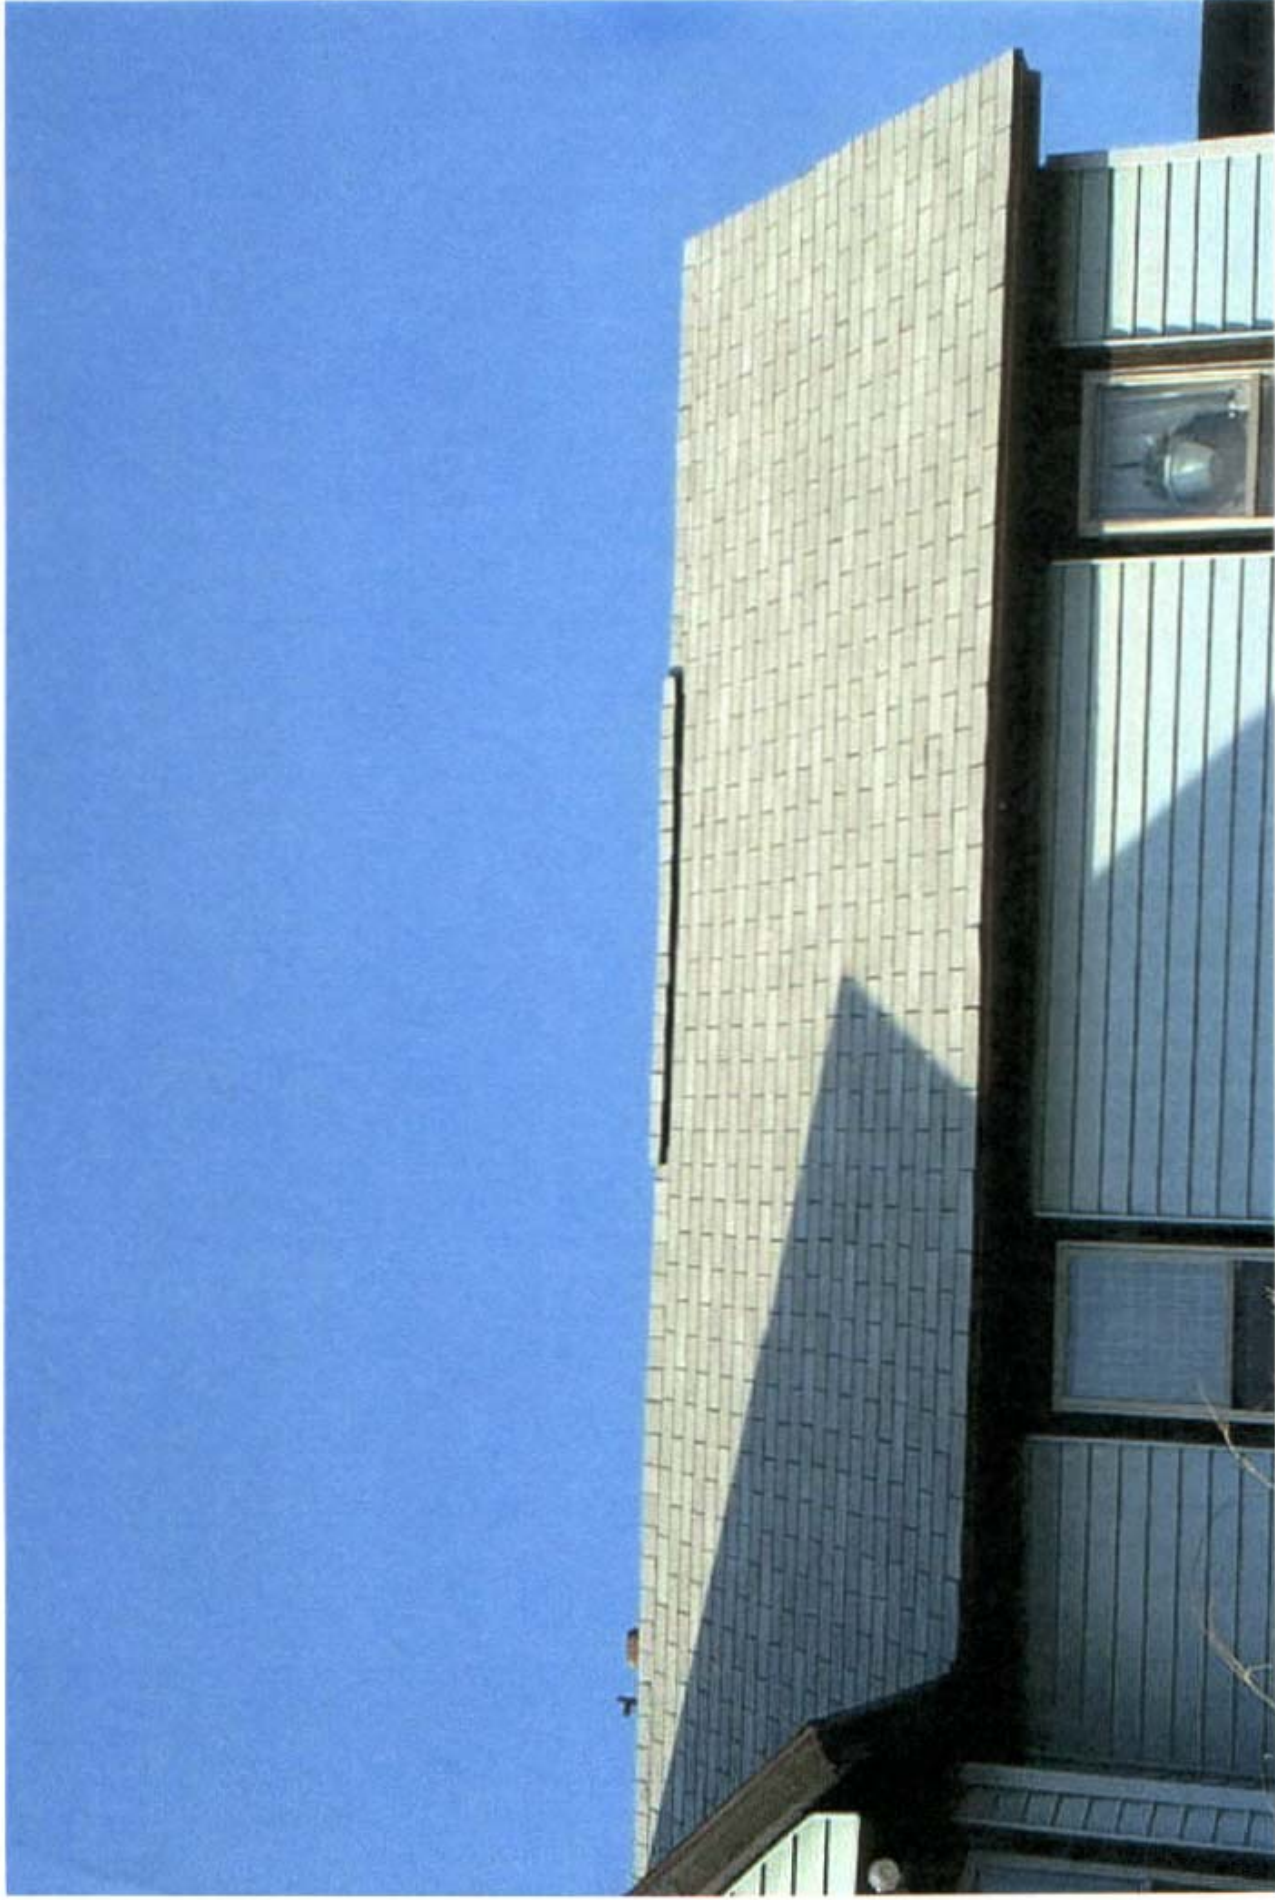
Here is one of the exceedingly short ridge vents. This one is about a third of the standard length required for proper ventilation. Ridge vents are supposed to extend across the whole peak and stop about 1 foot from the ends. (Photo by Professional Home Inspection Services)

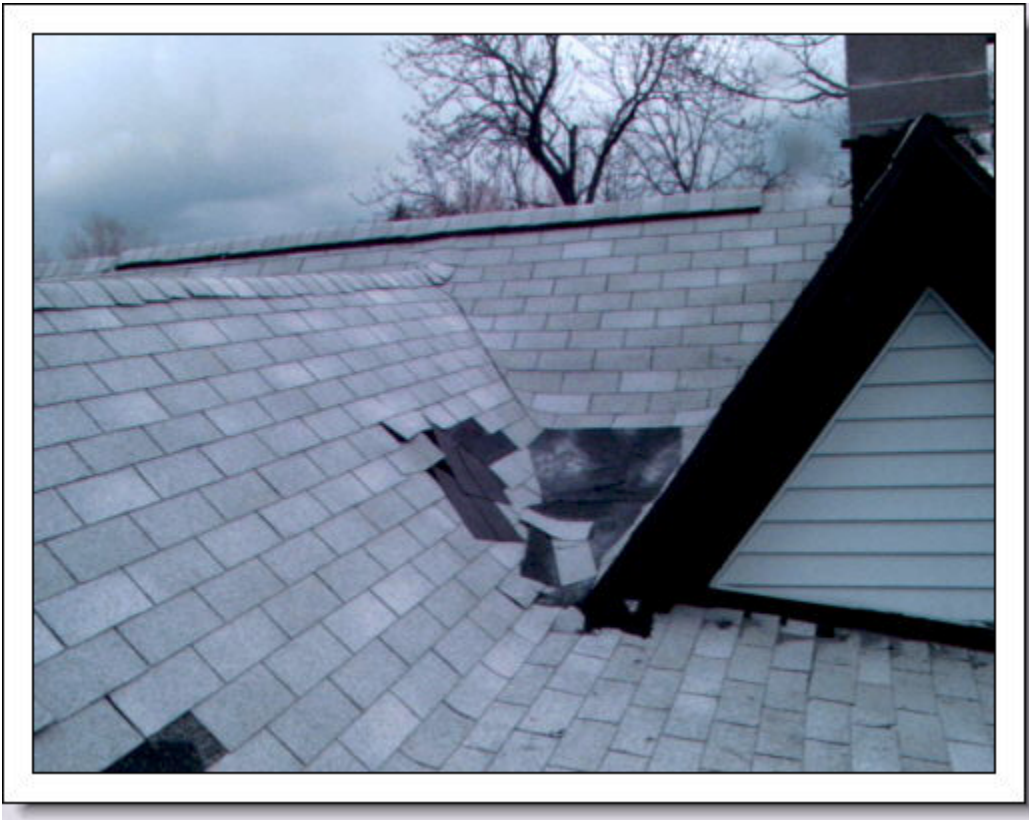
Here are some pictures of the shingles that were blown loose on 4/20/2004. April 18 saw temperatures near 70°. These temperatures should have sealed the shingles. April 19 had wind gusts of only 50 MPH. Another roofing contractor and I (the home owner) went up on the roof to repair the shingles, and took the following pictures on 4/26/2004. The roofing crew used too much pressure in their nail guns. Thus, they drove the nails right through the shingles.

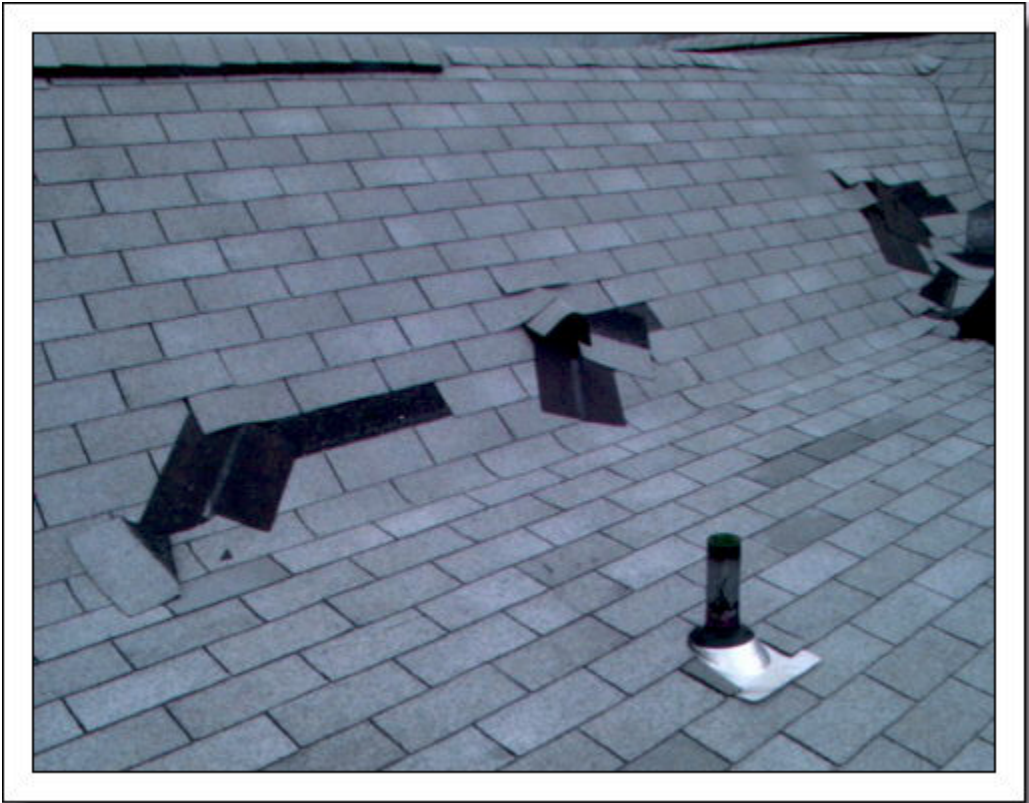
More shingles blown loose on 4/20/2004.

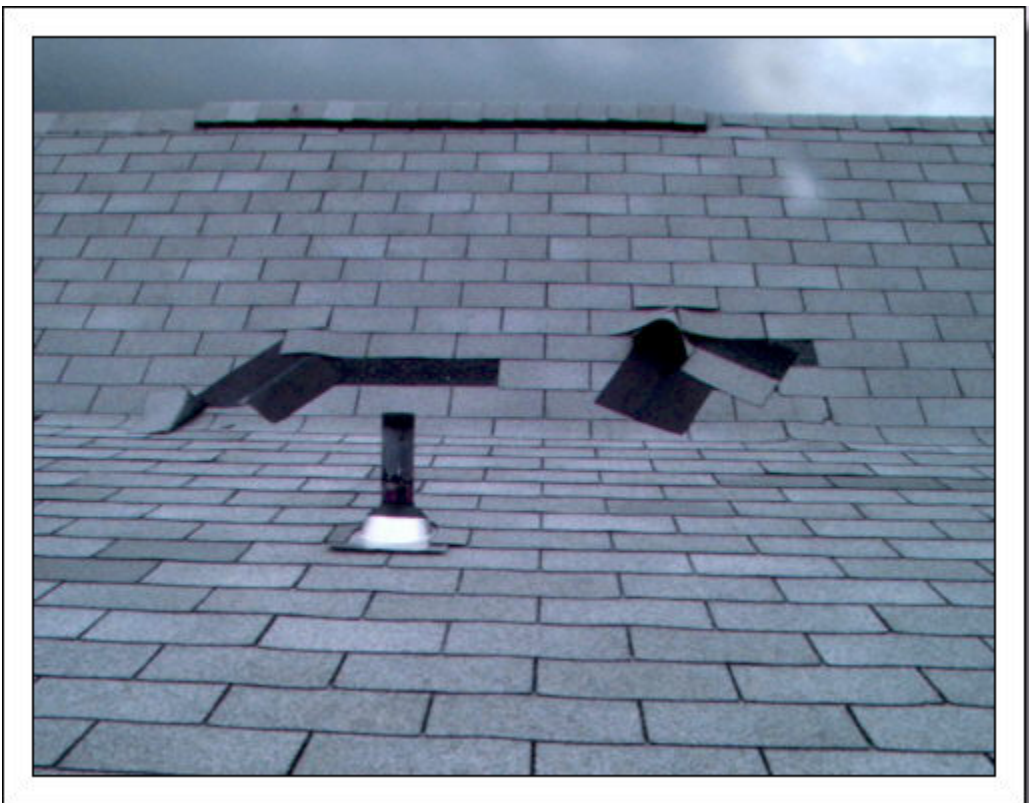
Note the vent boot is not even nailed down.
