# Roofing Infractions

RE: Inspection of ***GAF Materials Corporation*** Roofing System

As per your request, I inspected a GAF Roofing System at the residence located at 17029 Gulf Road, Holley, NY on March 29, 2004. This letter is to document my findings.

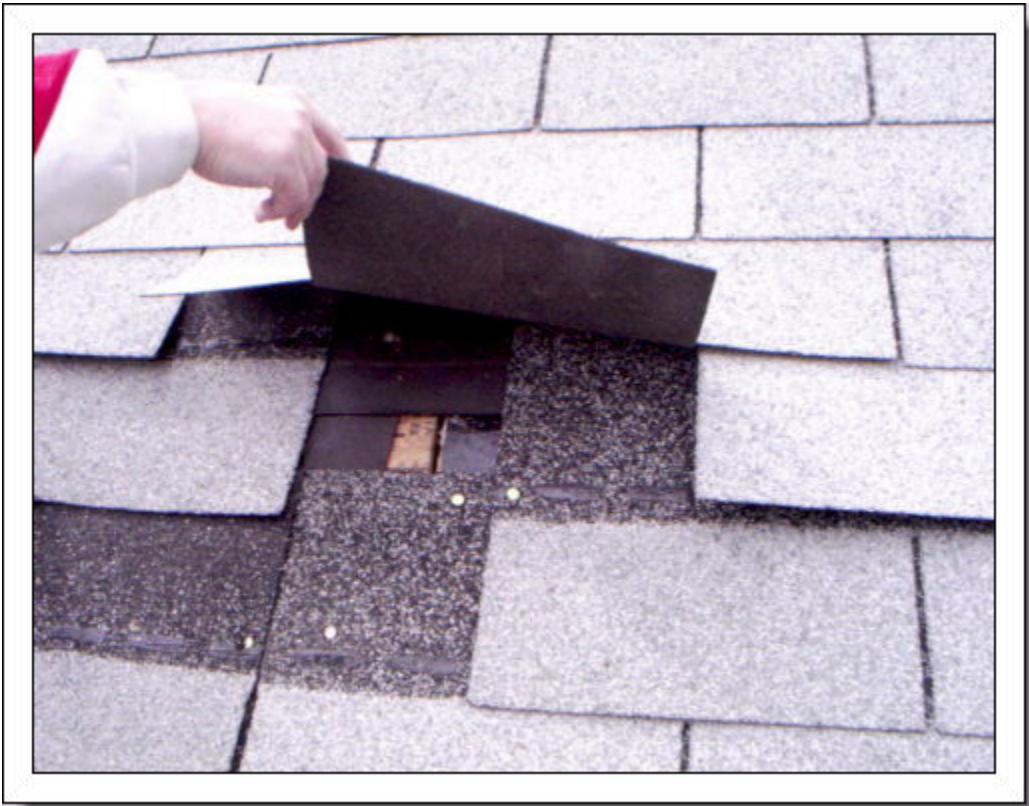
We spotted this as we were replacing one of the blown off shingles.

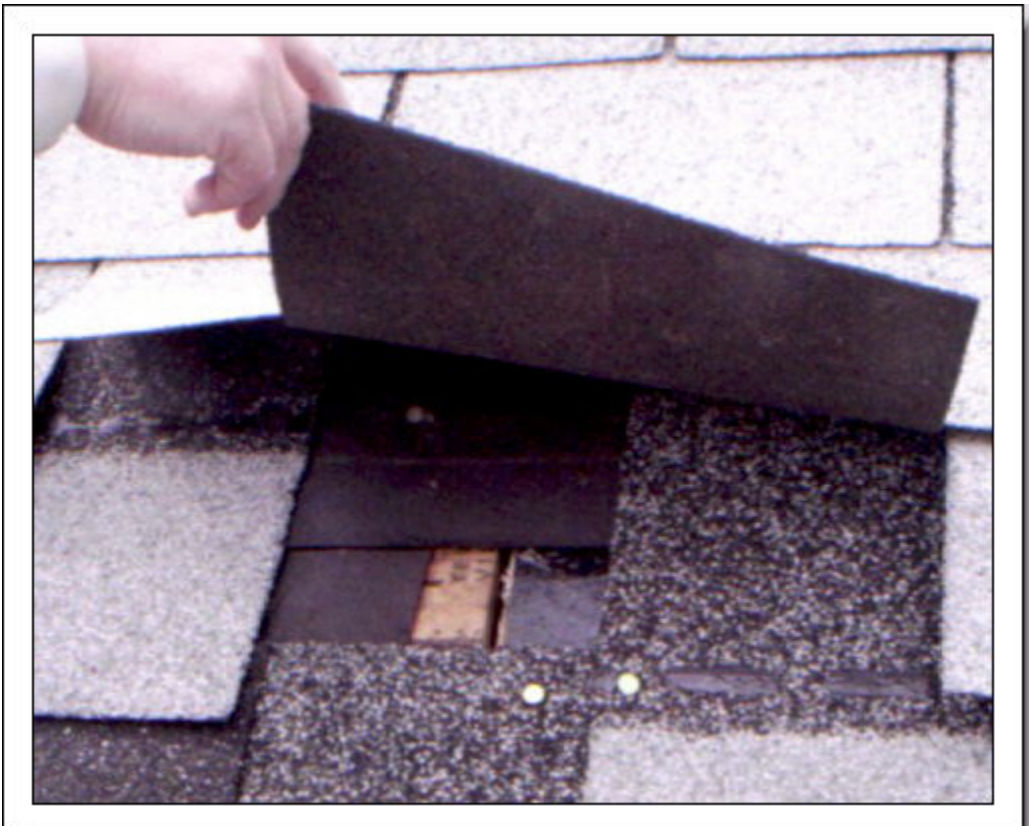
Note the gap between the Advantech that doesn't even have tarpaper over it.

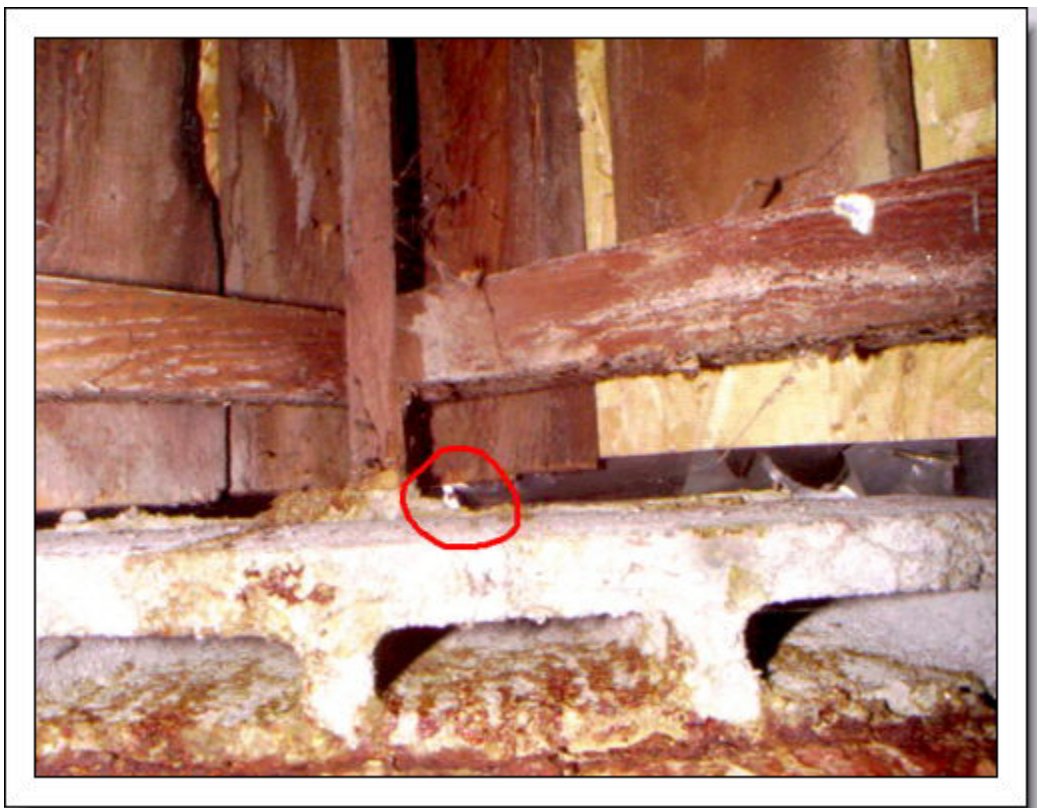
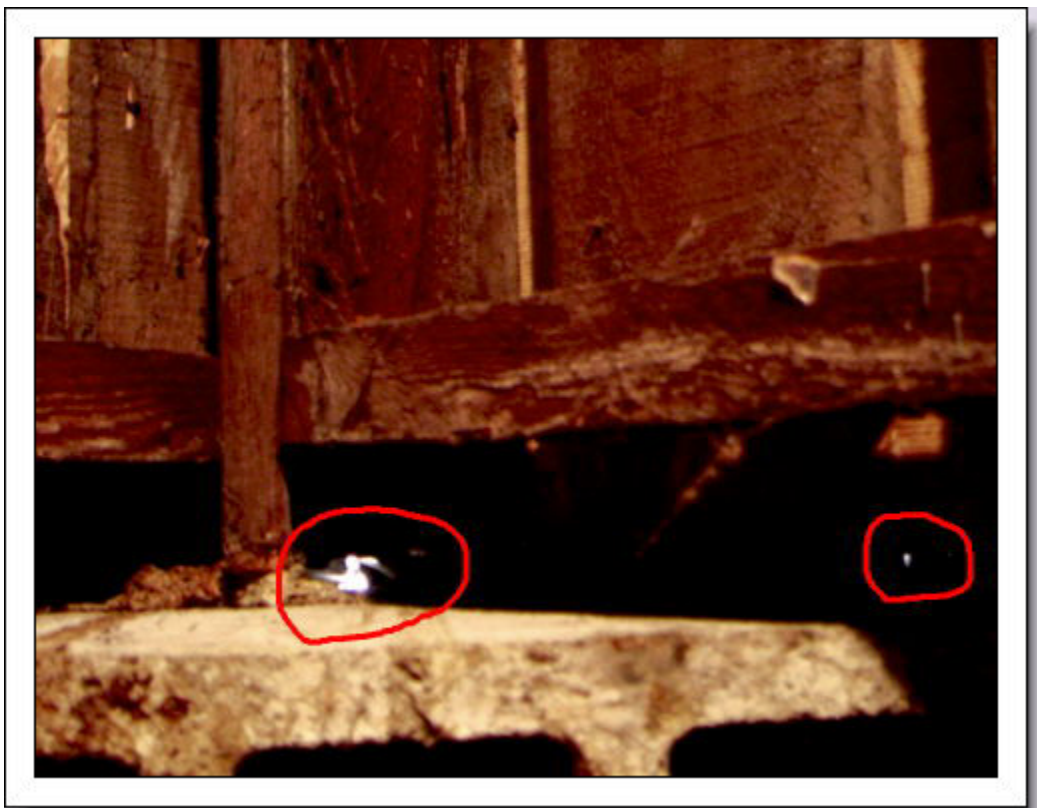
#4- Extremely poor transitions between the roof and chimney flashings and the roofing were visible. Globbs of roof cement, with gaps at the chimney were observed. Daylight can be seen from the attic around the chimney. This will produce ongoing leaking and should be corrected at once. . A new roof would not have this unsightly condition.  
Approximate cost to correct - \$300 to \$400.

Here are some pictures of the daylight shining into the attic around my chimney.

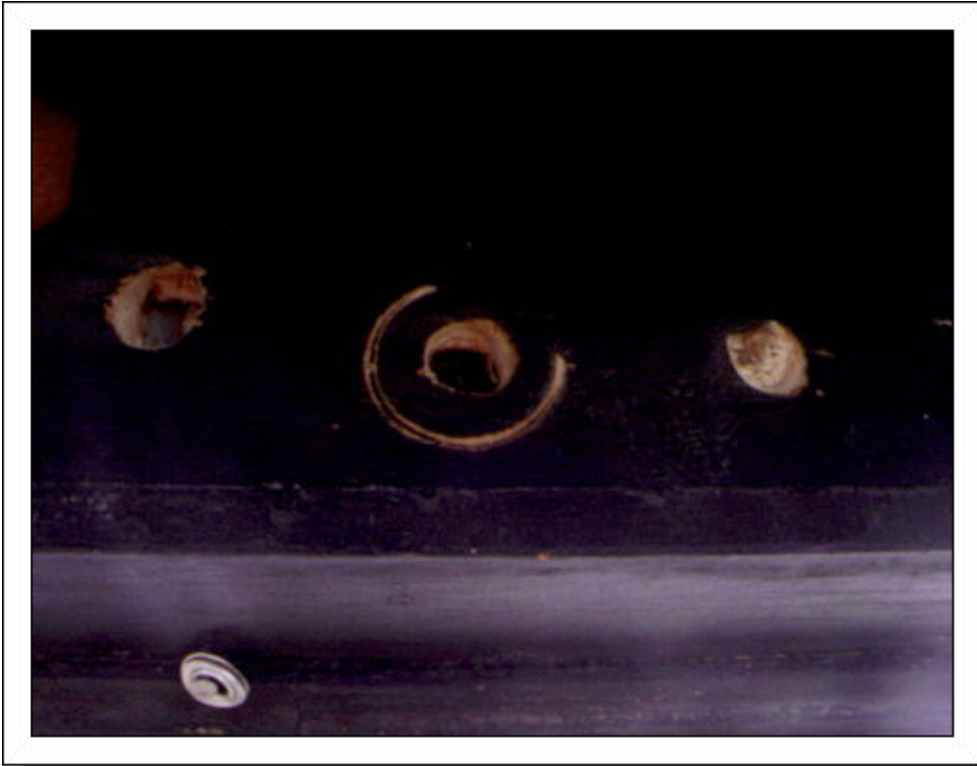
This shows that the work crew had a 3-inch hole-drill available, but failed to drill three 3" holes – the minimum required for proper airflow. In fact, the third 1" hole is not even drilled through. Note the nail with the grommet on it is one of several left behind by the crew. They used these to secure tarps, but were not supposed to leave them behind.

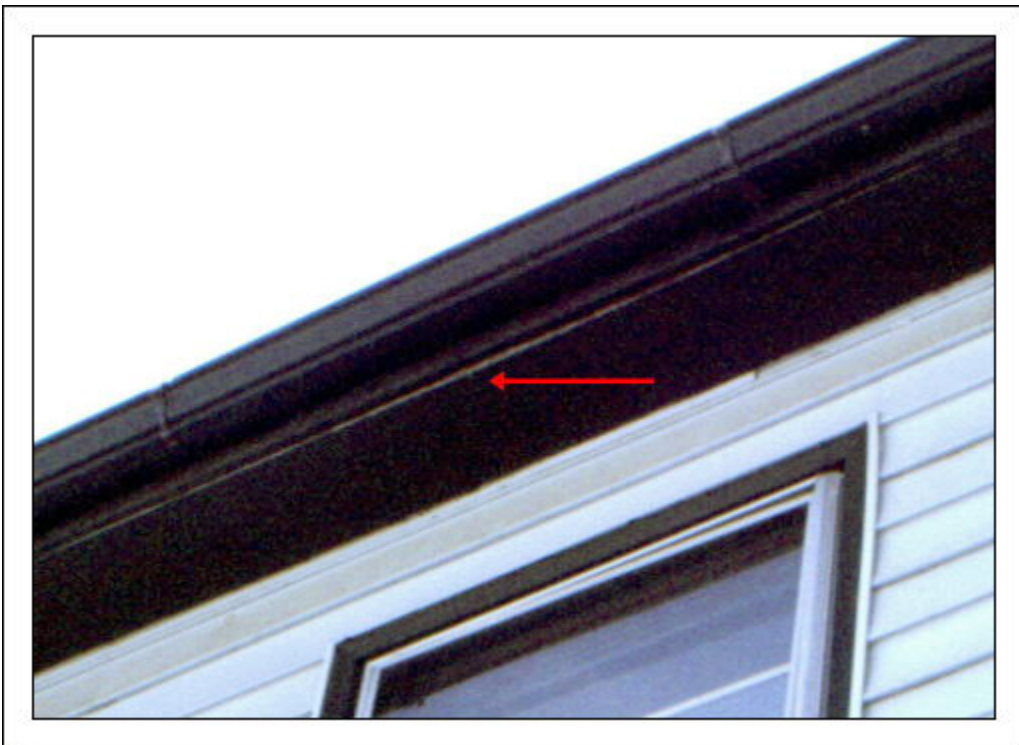
This is a split caused by ice damming due to the contractor's installation of shingles and leak barrier only part of the way up a slope of less than 1.75 / 12. NYS Building code prohibits use of shingles on a slope of less than 2 / 12, and GAF specs require the use of an adhesive membrane on a slope of less than 2 / 12.

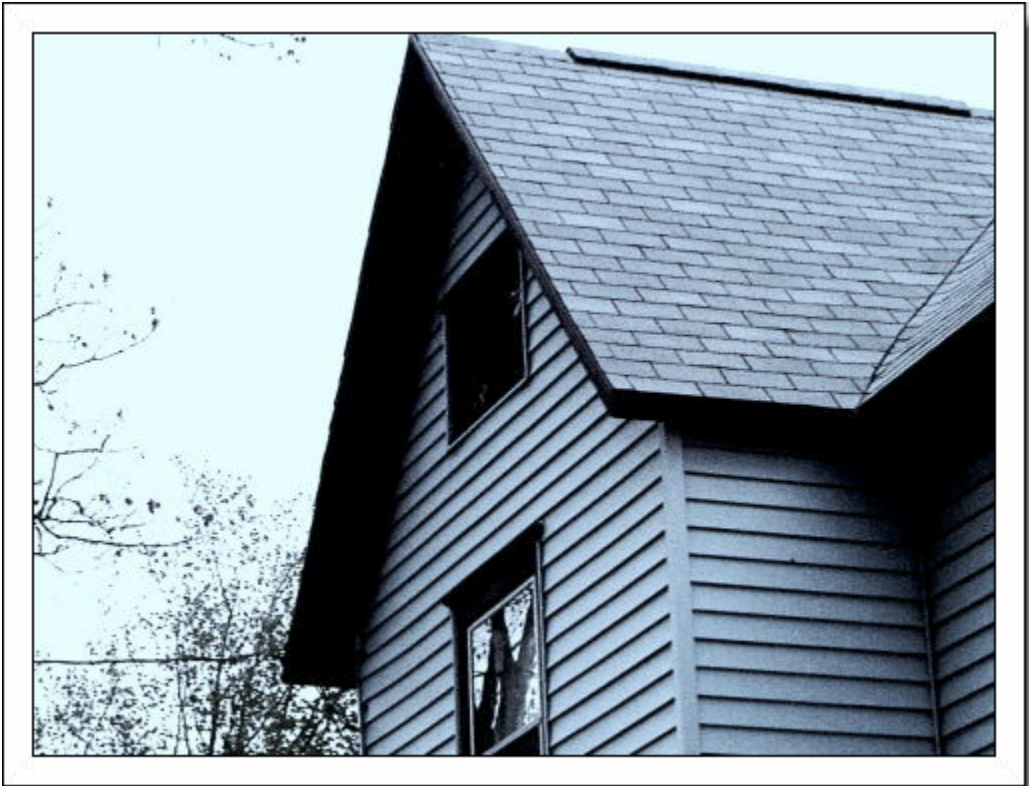
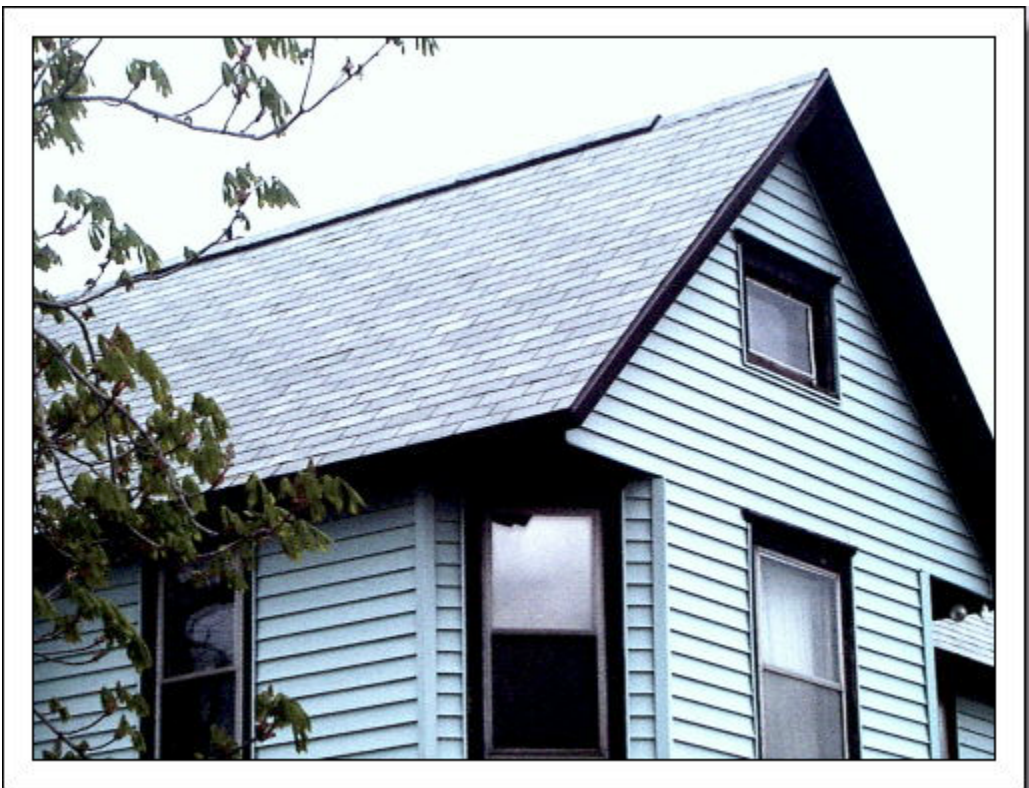
The next two pictures show that the crew improperly installed the bottom row of shingles according to GAF Installation Instructions. The starter course is supposed to have full shingle tabs at the bottom outside corners, not just a 4" partial tab.

This resulted in the misplacement of all of the shingles. These tiny tabs at the very edge of the roof allow wind to easily get under the shingles, promoting lift and blow-off.
