Perilous Stairs
by Pecorella Contracting and Consulting
126 Frank Street Medina, NY 14103

Inspection Report by Superb Carpenter

May 23, 2004

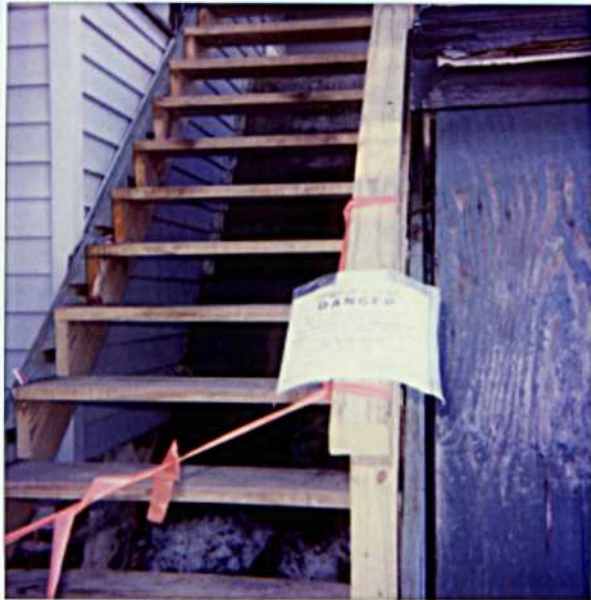
I'm surprised that no one got injured in the two months that the structure was there. This stairway was an accident just aching to happen. It is abundantly clear that the entire fabrication was in violation of the codes, rules, and regulations of NYS, which would have required proper diligence and care during the erection of a stable stairway. Obviously, the Code Enforcement Officer had no choice, but to condemn this contractor's work as unsafe.

Shows that the stairway was condemned

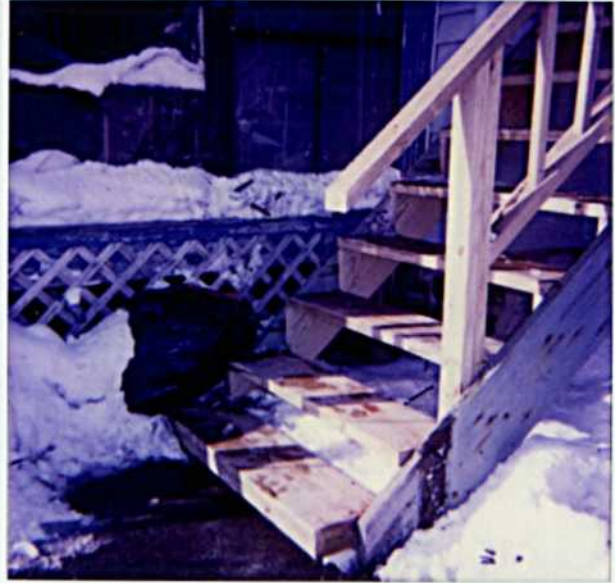
The worst factor was that new stringers were attached to old, deteriorated wood (which should have never been considered for use in building this staircase) and very poorly at that! The new wood stringers had very few screws driven into the old wood, and there was a gap of approximately 1/4" between these on one side. In addition, the one old stringer was barely secured by only a few nails and screws to the house's outer wall. The opposite old stringer had none securing it to anything.

Shows how the stairway used the old, rotten wood as its basis. Also shows the span in between the spindles.

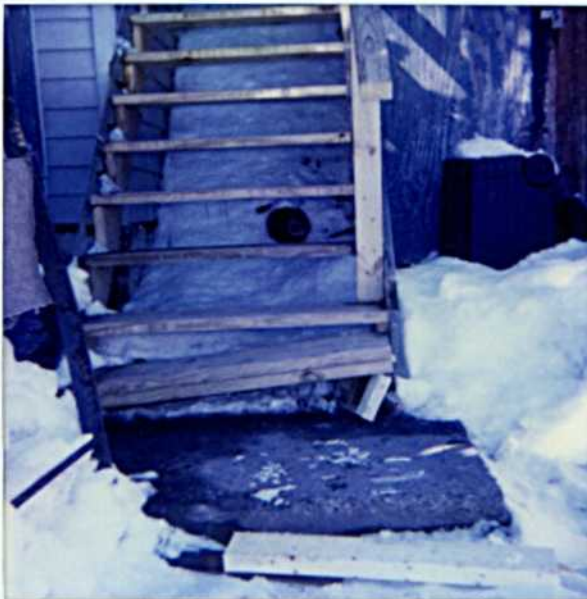
The bottom step was partially detached when I first looked at the stairway. Upon investigation, I found that this occurred because the stringer on both sides supported only the rear 4.25 inches of the step tread. The front 5 inches were not supported by anything. This scenario made it inevitable that the step would break loose as people walked on it.

Shows my "liftable" bottom step; propped up by a white board for the purpose of taking the picture.

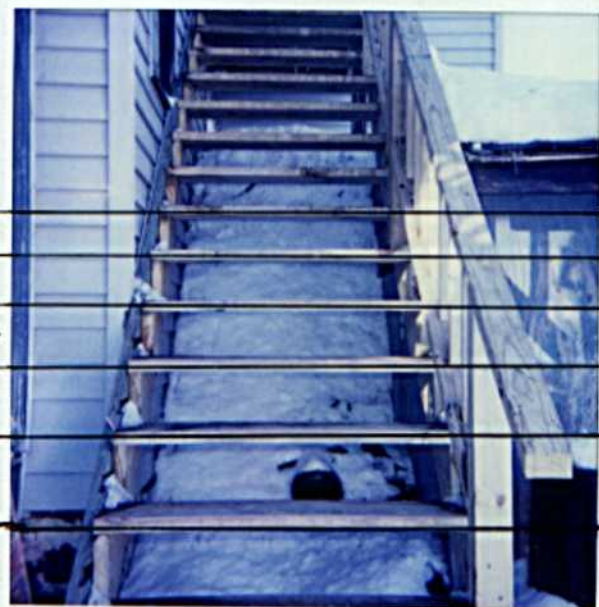
I noticed that the fifth step was not near level - a dangerous slip factor when it becomes icy.

These lines were drawn to accentuate that the step below the area marked with the small arrow was not level.

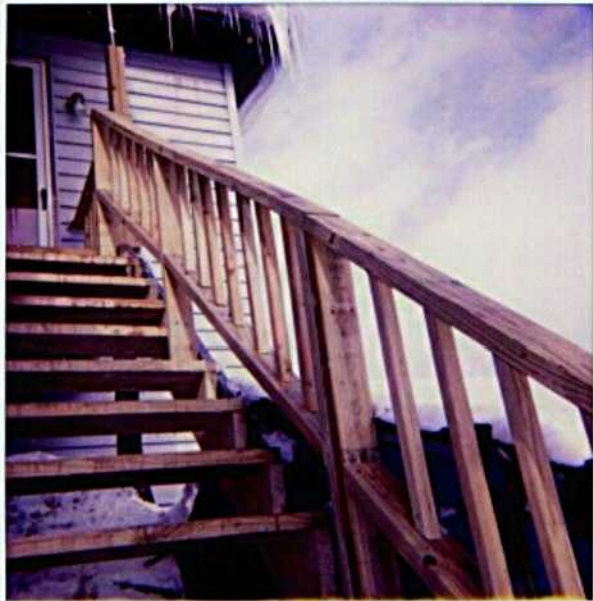
The handrail violated many building codes, and was ridiculous looking. The spindles were not parallel to each other, and varied in length. Measurements of the spindle lengths in the top

section of the handrail best illustrate how insolently this contractor built this handrail. The spindle at the bottom of this section measured 20" and the spindles at the top of this section measure 16 3/4". Even two handrail uprights weren't parallel to each other, and therefore both could not have been perpendicular to the ground. Distances apart measured 61 1/4" at the top, and 55" at the bottom.

Shows how crooked and ugly the handrail was. Spindles were not placed evenly or parallel.

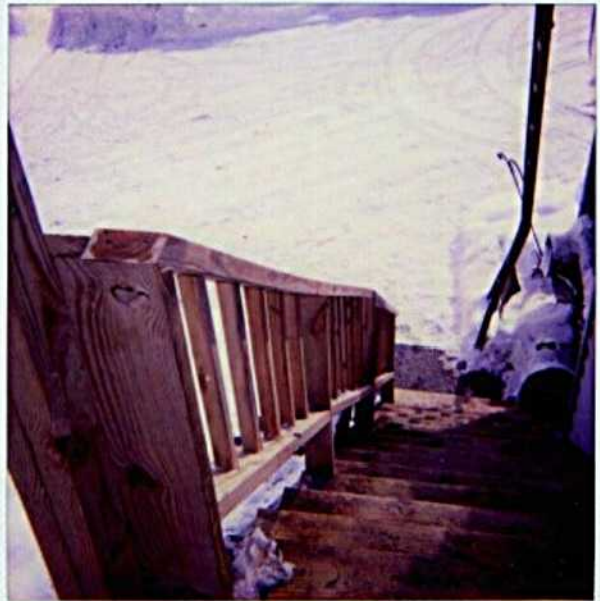
There is still another defect in the handrail. All spaces should be no wider than 4" so a toddler's head cannot pass through. I found the spaces in between the railing's spindles were 6" up to 8 3/4" wide. A toddler at the second story could fall through these wide spaces to his / her death.

Spans were too wide, up to 8.75 inches - Code is less than 4 inches

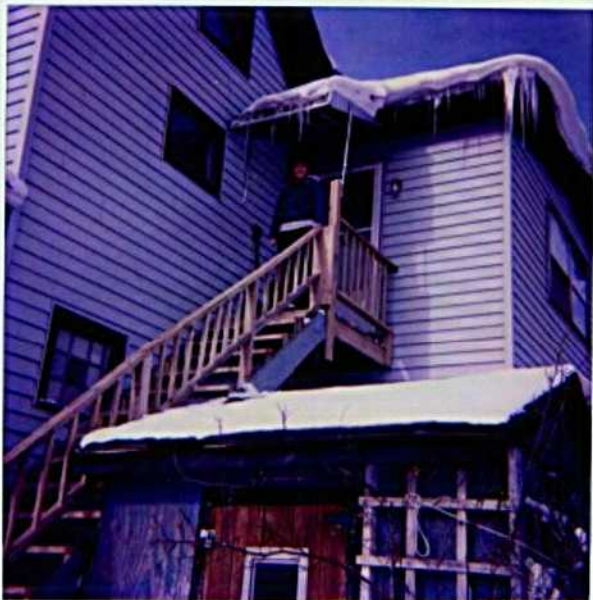
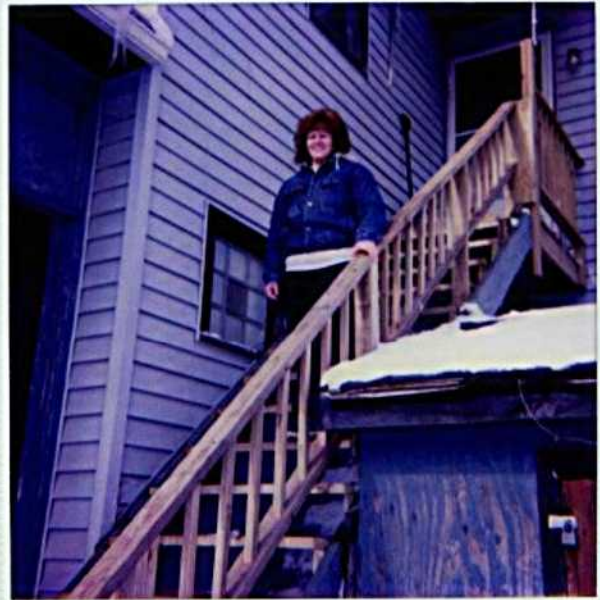
One upright was 39" tall, and the upright at the top was only 33" tall (too low for the standard). A person automatically expecting the handrail at the top to be a uniform height with the rest of the handrail might possibly grab for the rail and miss, as the handrail would have been 6" below their reach. Injury or death is a real possibility, especially since this resulting fall would have been from two stories high.

These two pictures show that the handrail was different heights. My arm is straight at the top. Height = 33 inches

My arm is bent at half-point. Height = 39 inches

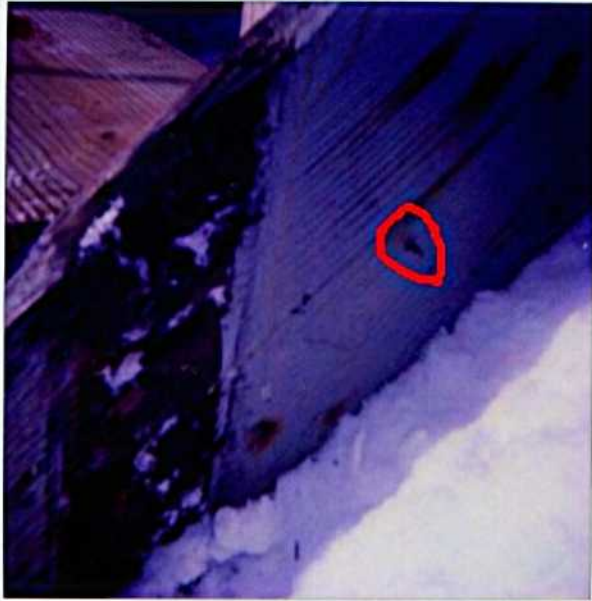
Shows the rotten wood that is the main support for the stairway. Also shows a screw point.

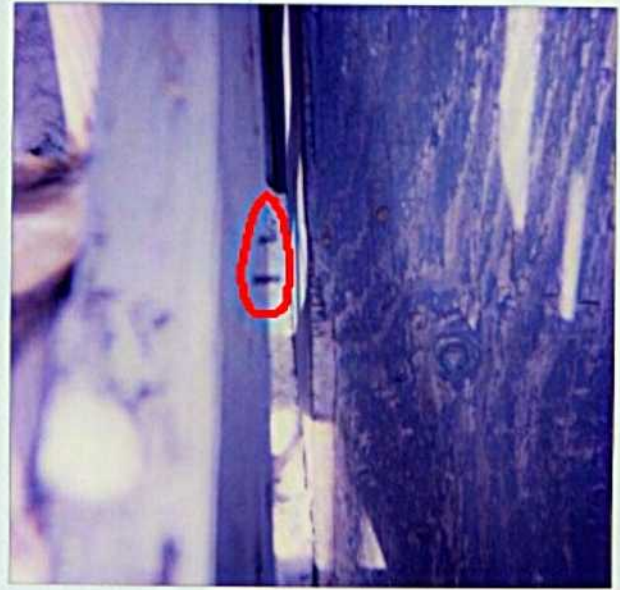
There were five tips of screws protruding out from the lower section of one old stringer where someone could walk by, and be injured. These sharp projections ranged in length from 1/4" to 9/16". It was hazardous just being next to these steps, let alone being on them.

Shows more screw points protruding out where they could injure someone.

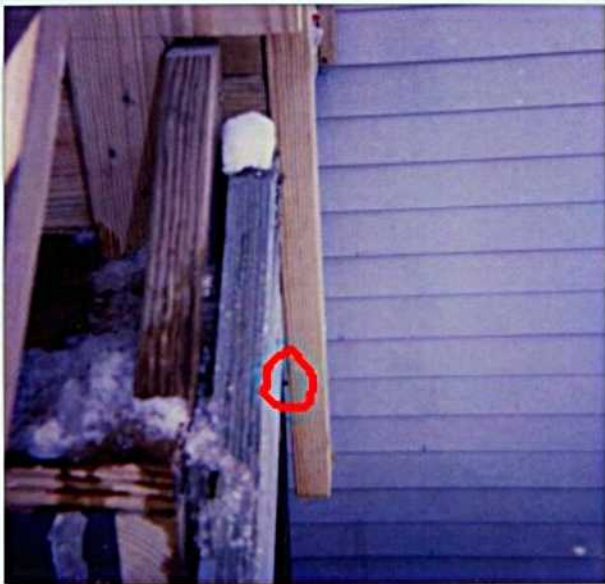
Shows the pitiful attempt at securing this board. You can see the one screw between the gap of new against old.

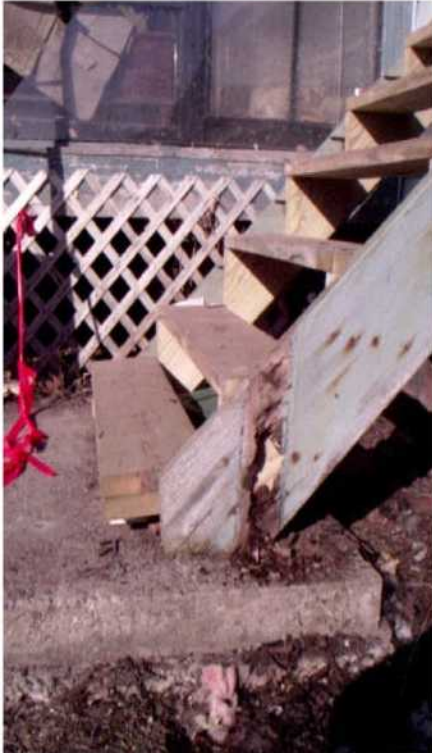
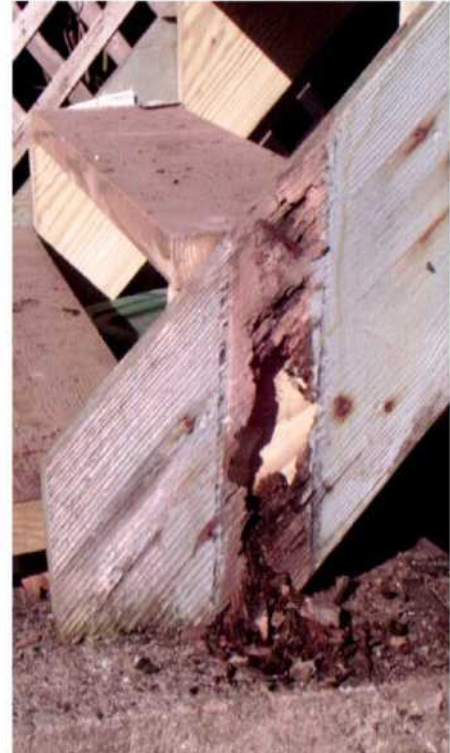
On the day that I dismantled this staircase, I tapped lightly with a hammer on one area of the rotten wood. The deteriorated wood crumbled away creating a hole measuring 4" x 4". A little more tapping, and I'm sure that the bottom few inches of the stringer would have fallen off.

As new contractor was rebuilding, he tapped lightly with a hammer on the rotten wood. This resulted in putting a hole clean through the rotten wood.

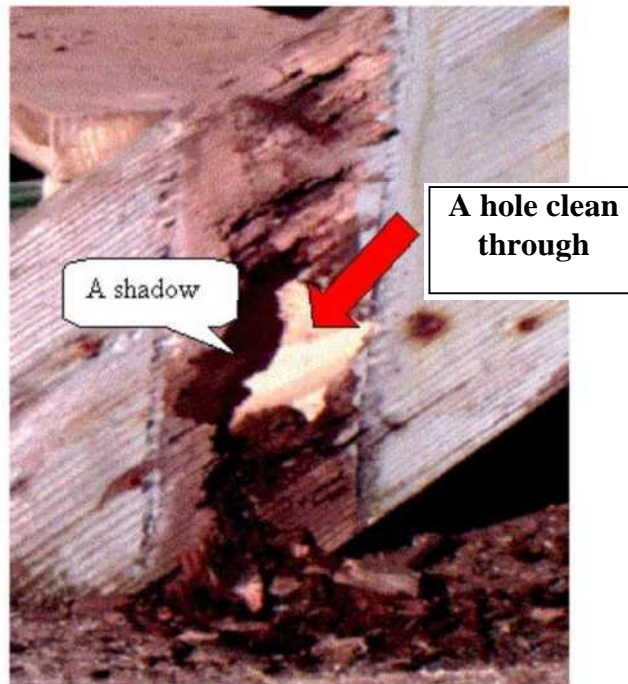
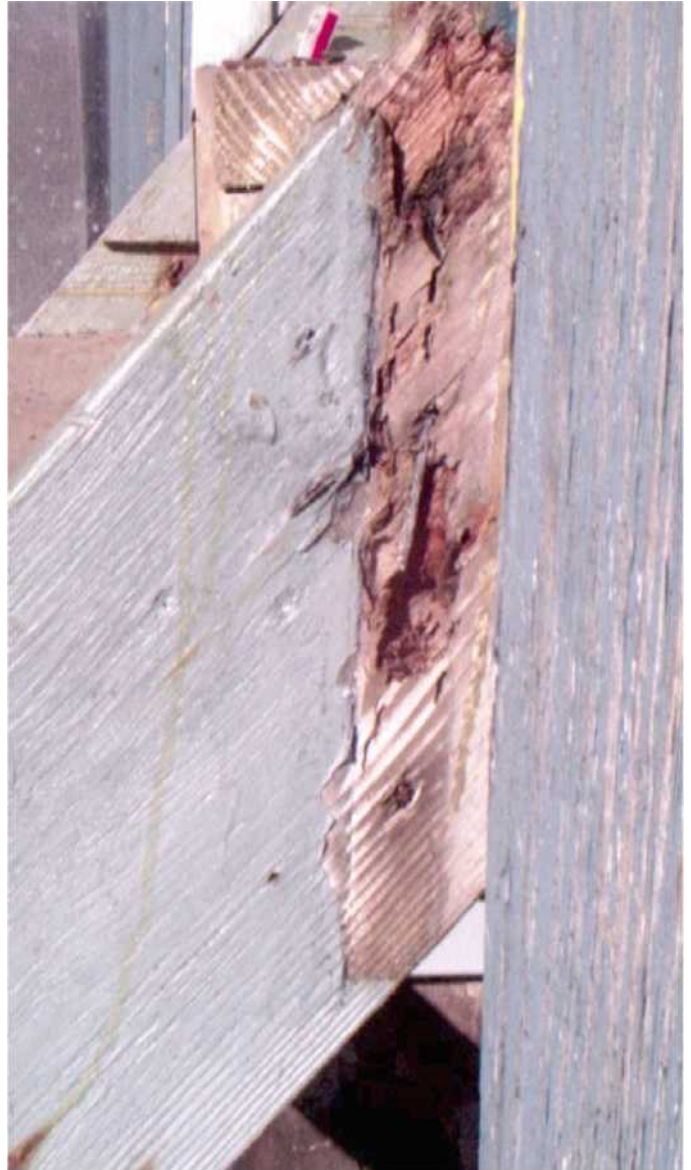
Another example of the rotten wood

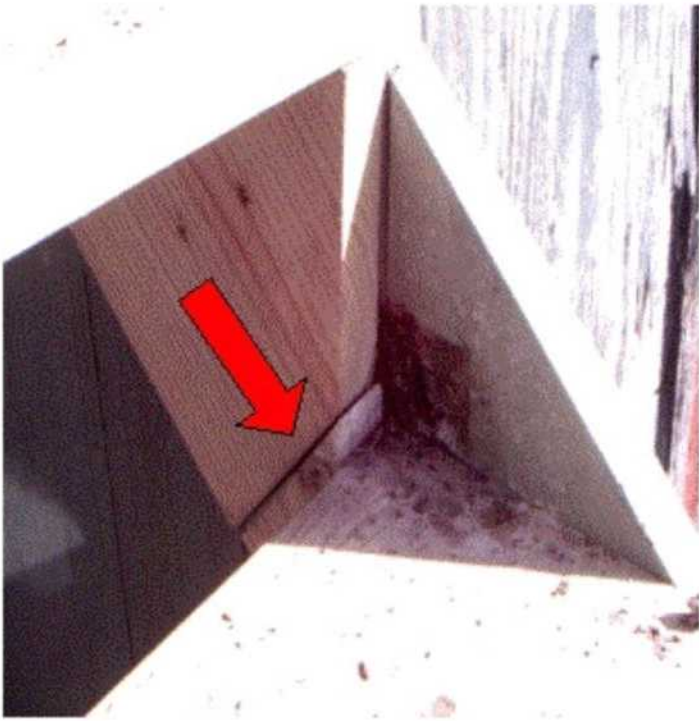
Lastly, any staircase over 10 steps is required to have continuous stringers that are notched for the treads to be inserted. The new stringers built by this contractor were not of a continuous length as they should have been for proper structural support. Three sections measuring 5.5, 5.5, and 6 feet were fastened to the old wood. In essence, the deteriorated, crumbling, old wood was not used just for filler, but as the base for the new stairway. Also, I noticed as I removed the handrailing, that the joints of the stringers were extremely unsafe. The seams were at approximately a 45-degree angle to the ground. These seams should have (at the very least) been parallel to the ground. This configuration left this structure too treacherous for any occupancy, as it depended on the old crumbling wood as its main support. When the old wood deteriorates a little more, there will be nothing to keep the new wood from collapsing.

These pictures show the despicable method that Pecorella used to mount the new wood against the old-rotten wood. It is clearly shown that the rotten wood is the main support for everything above the bottom section. And then, this junction is slanted, making it virtually unsupported, and able to slide right down. The only thing preventing this slide are the screws holding the new wood to the rotten wood. Once the rotten wood deteriorates a little more, the stairway will fall apart, probably with a person on it.
