Perilous Stairs
by Pecorella Contracting and Consulting
126 Frank Street Medina, NY 14103

Inspection Report by Superb Carpenter

May 23, 2004

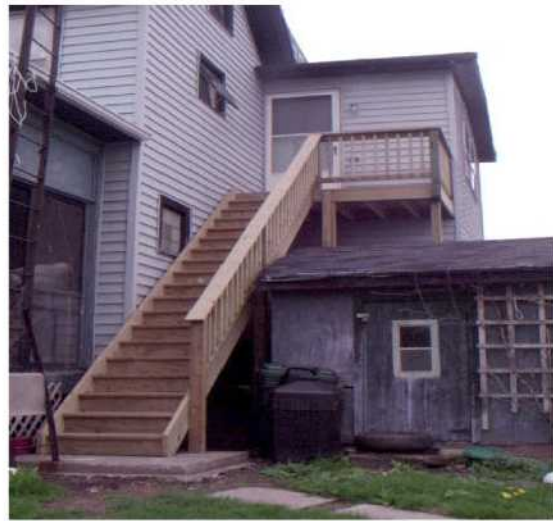
There is still another defect in the handrail. All spaces should be no wider than 4" so a toddler's head cannot pass through. I found the spaces in between the railing's spindles were 6" up to 8 3/4" wide. A toddler at the second story could fall through these wide spaces to his / her death.

This is a picture of the top section of my ugly, crooked hand-rail. Look at the span just above support (about midway). That span, which is required by NYS Code to be less than 4 inches wide so a toddler's head can't fit through, is actually 8.5 inches wide.
